Bonriki Inundation Vulnerability Assessment

Groundwater Field Investigations
Bonriki Water Reserve, South Tarawa, Kiribati

SPC Technical Report SPC00009

April 2015

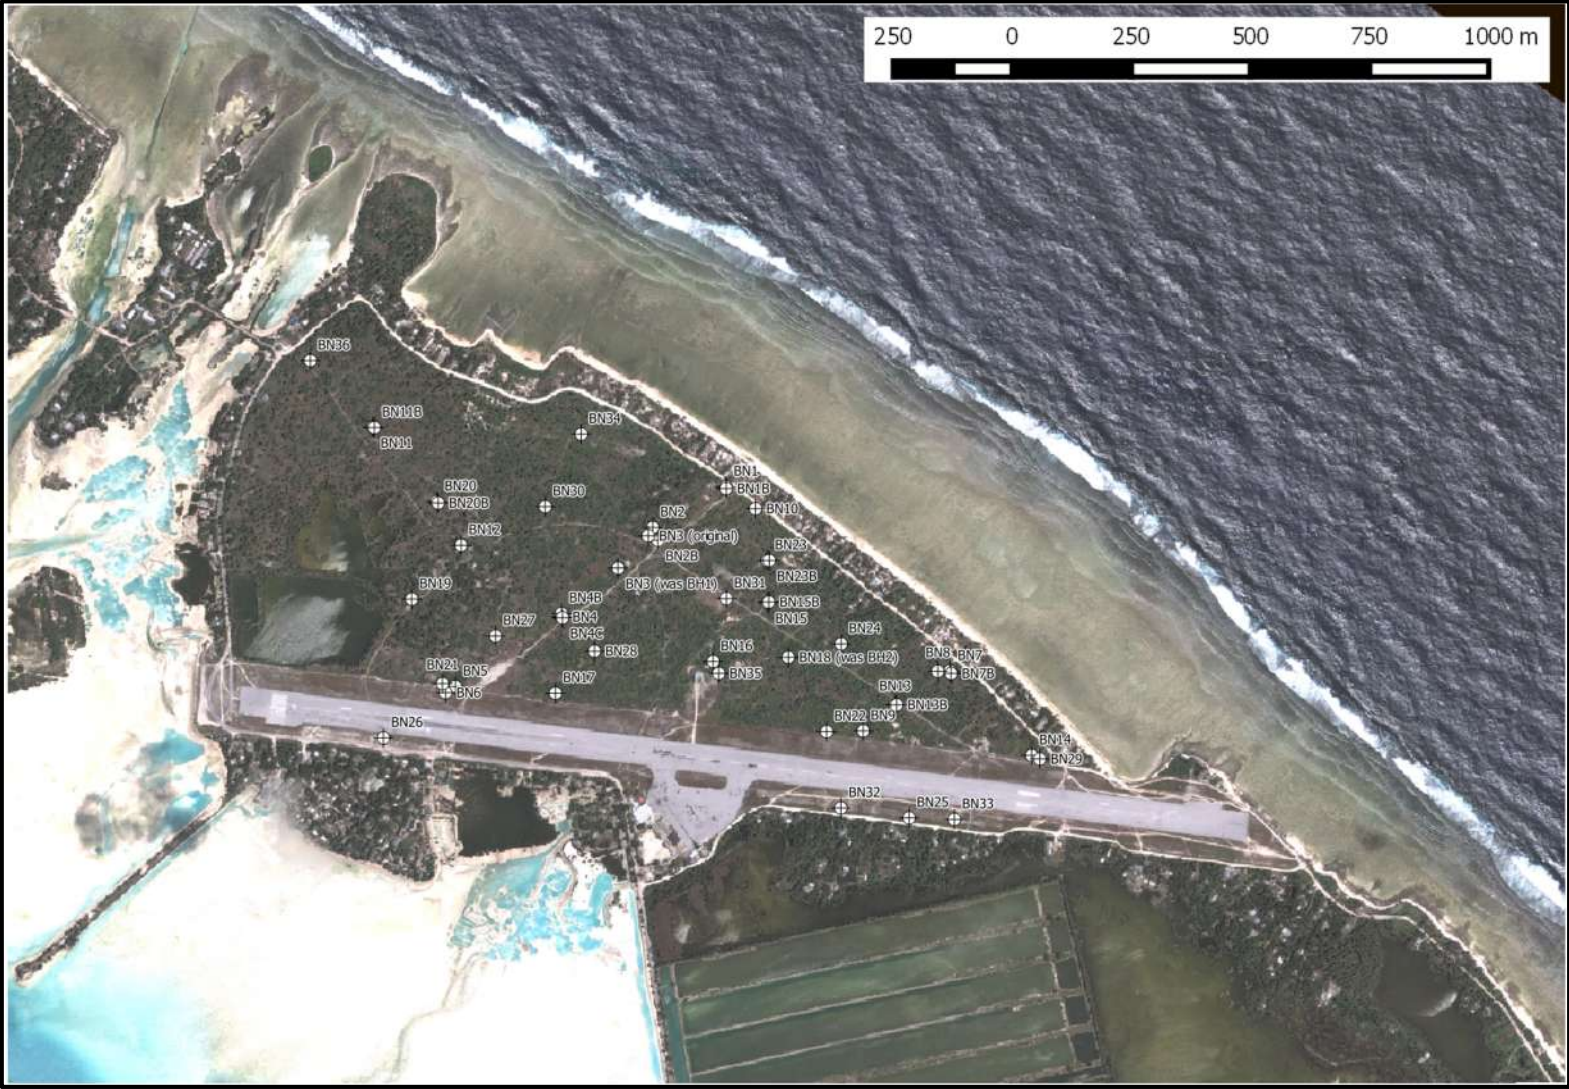
Figure 9: Monitoring borehole sites 1980–2014, Bonriki water reserve, Bonriki Tarawa.

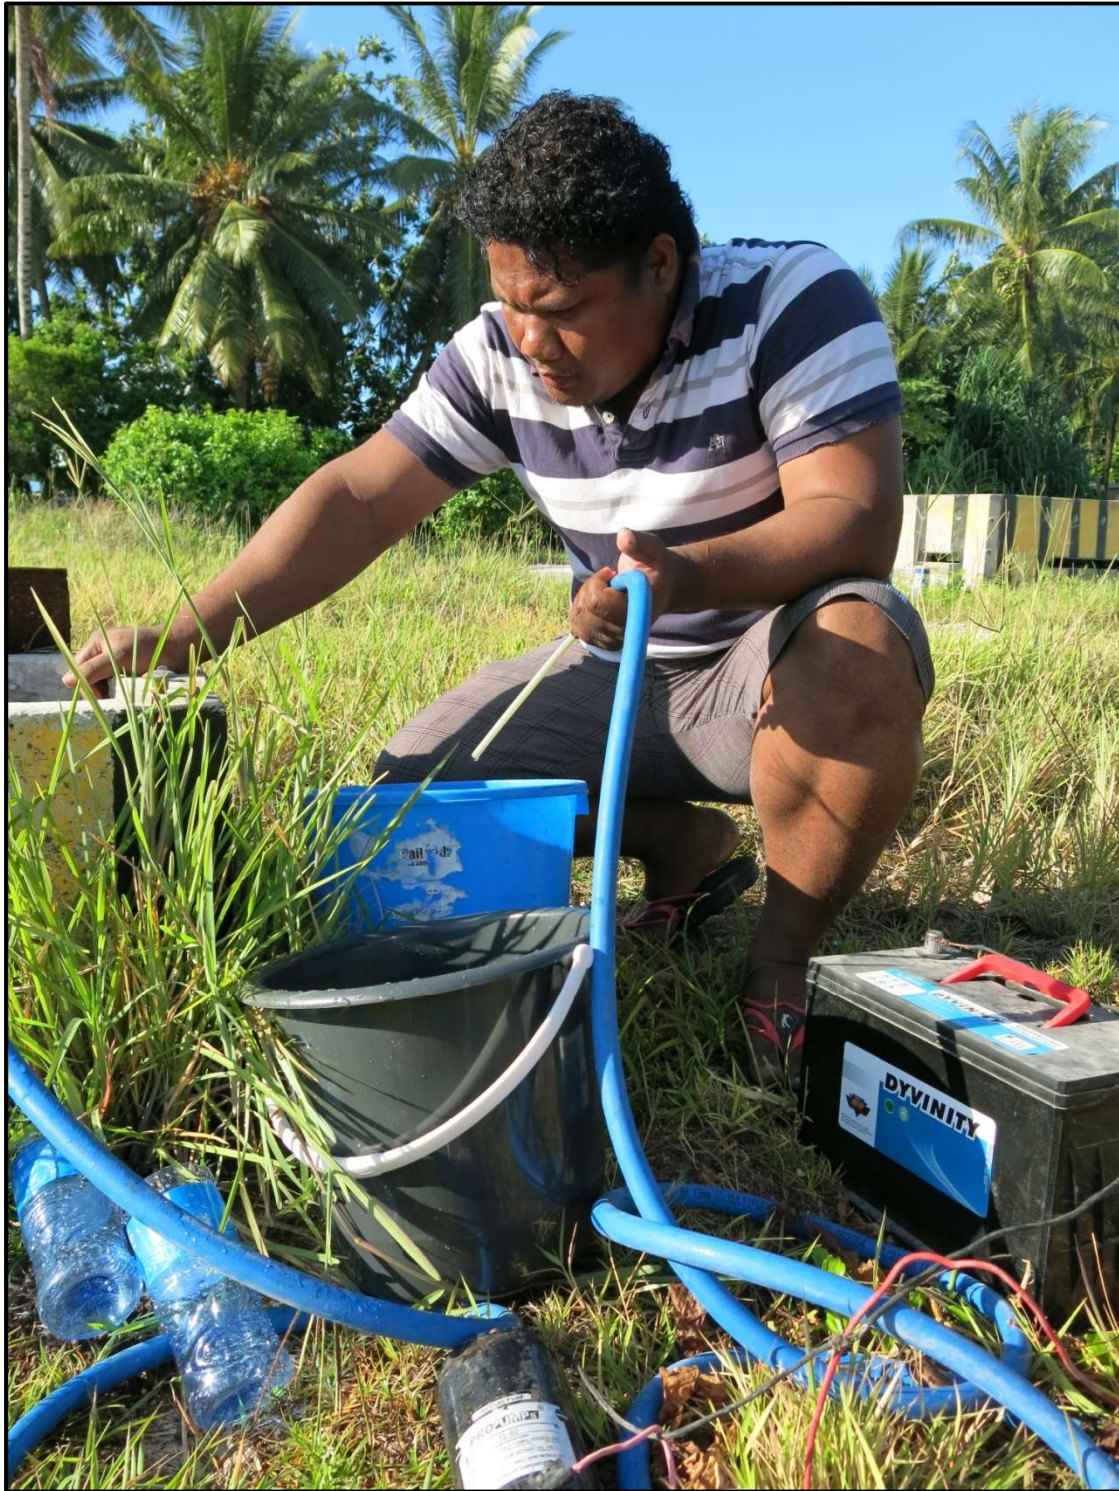
Figure 12: Sampling equipment used by MPWU staff members in the field, 12-V diaphragm pump (foreground), used to abstract water from 8-mm sampling tubes that can then be measured for salinities or other purposes.

Samples were taken by connecting a 12-V diaphragm type pump to the sampling tube and abstracting three sampling tube volumes prior to sampling into three separate sampling containers and measuring the salinity and temperature with a calibrated TPS W84 TDS and conductivity meter. Water level data in the 50-mm piezometers were also recorded along with the time and date of each visit, and general conditions or issues observed during the sampling.

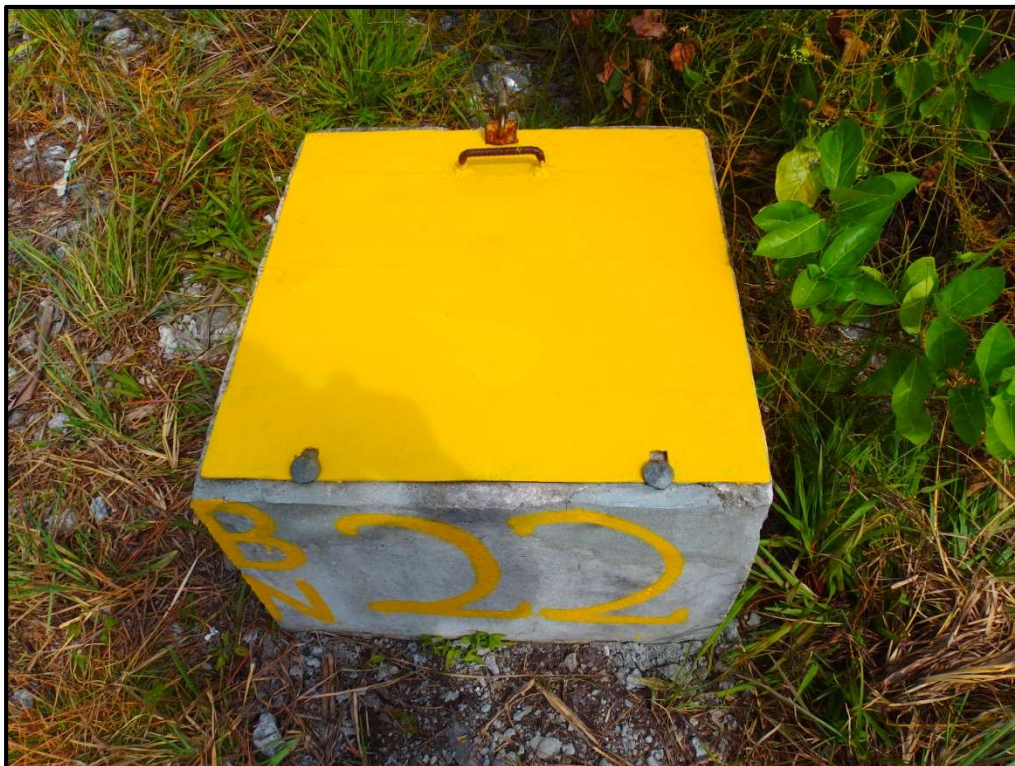
Figure 14: The steel monitoring borehole lids have been repainted to extend its life.

In addition, monitoring boreholes with steel lids were repainted to prolong the life of the borehole protection installed (Figure 14), and damaged cement monitoring borehole protection boxes were repaired where possible. An audit of the monitoring boreholes for recommended rehabilitation works is provided in Annex 3.

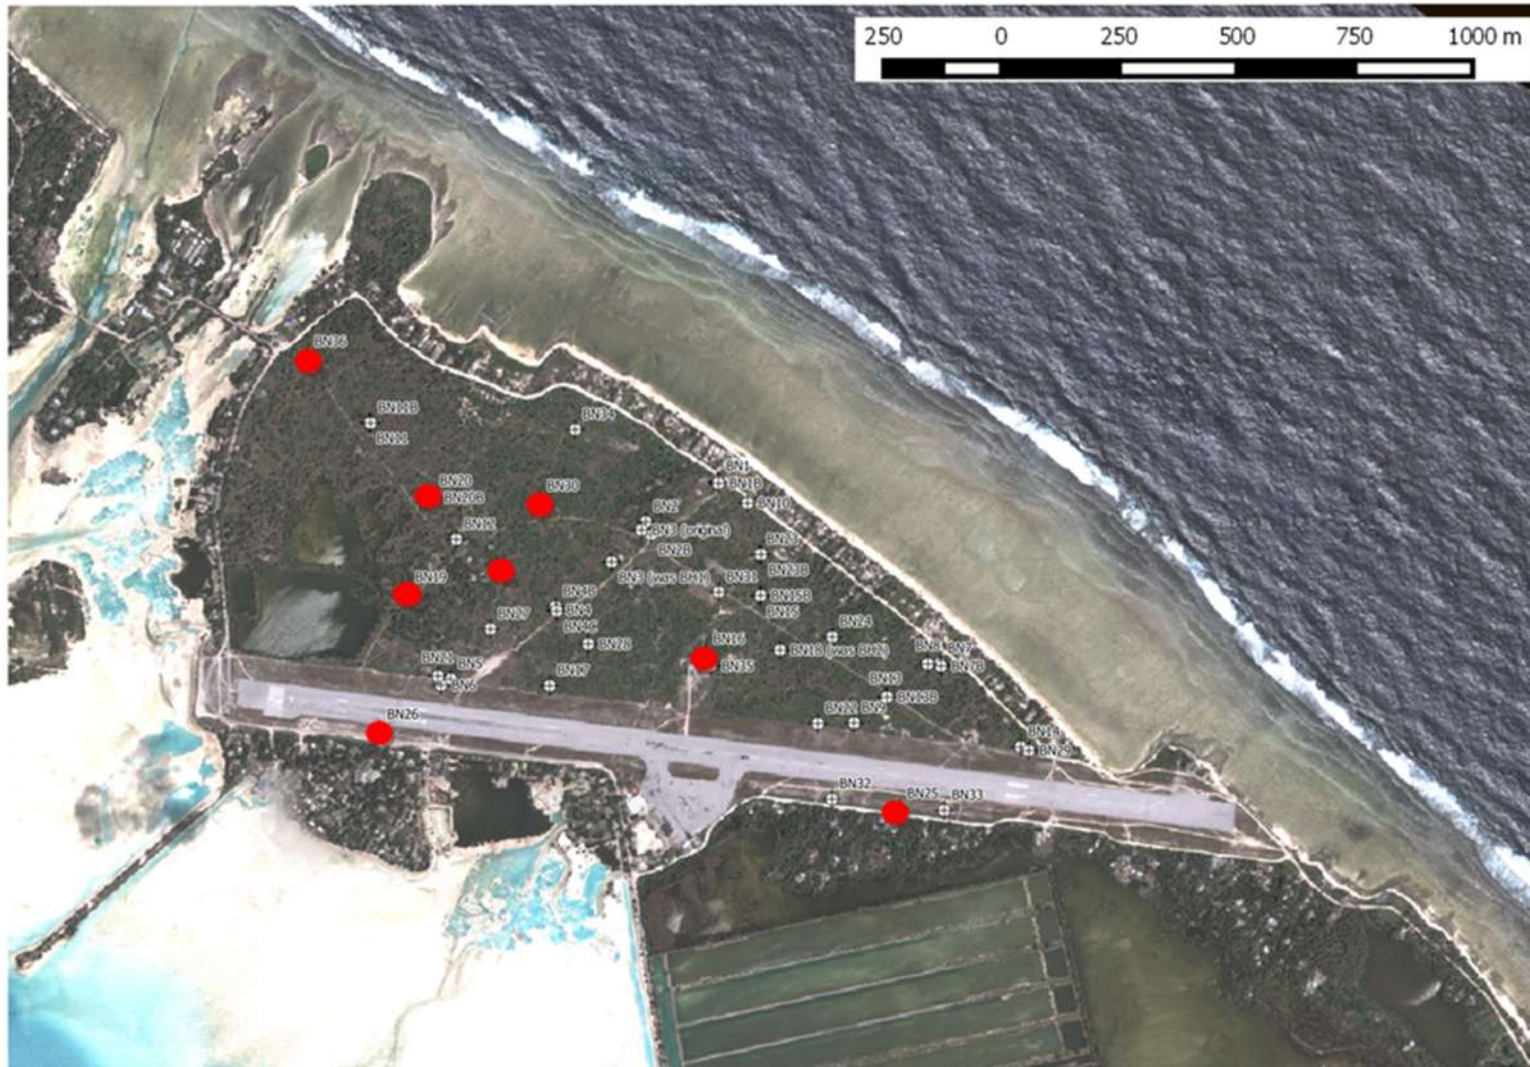
Figure 15: Location of recommended future monitoring boreholes sites or redrilling.

In some cases, the sampling tubes were not constructed to sufficient depths to allow the thickness of the freshwater lens to be determined under all conditions. This is a limitation of the monitoring boreholes and reduces the effectiveness of the site to be able to observe changes in the freshwater lens due to climate and abstraction impacts over time. In a number of cases, monitoring boreholes sites have had their sampling tubes damaged or destroyed, which further limited access to information at important sites, thus making interpretation of the remaining data more difficult. It is recommended that additional or replacement monitoring boreholes should be constructed to sufficient depths to ensure that the entire profile of the groundwater from the fresh to the saline

water can be sampled in all climatic conditions. The proposed monitoring sites that should be considered for redrilling are presented in Table 4.

Monitoring borehole site replacement	Minimum depths for drilling	No. of sampling tubes	Comments
BN16	30 m	9 sampling tubes Sampling tubes at 3-m intervals below the water table 3, 6, 9, 12, 15, 18, 21, 24, 27, 30 m	This monitoring borehole site was destroyed due to sand mining activities; however, it is a critical borehole for the monitoring of the water reserve, and so it is recommended that the monitoring borehole be redrilled at either the original site or at the location of BN35
BN30	21 m	7 sampling tubes Sampling tubes at 3-m intervals below the water table 3, 6, 9, 12, 15, 18, 21 m	Replacement for destroyed borehole. Previously located between galleries 14 and 15.
BN19, BN20, BN25	BN19 – 30 m BN20- 30 m BN25 -27 m	10 sampling tubes for BN19 and BN20; and 9 sampling tubes for BN 25 Sampling tubes at 3-m intervals below the water table. 3, 6, 9, 12, 15, 18, 21, 24, 27, 30 m	Current boreholes are too shallow and do not extend into the freshwater lens sufficiently to be useful in monitoring, recommend redrilling and construction of new sampling tubes

BN26	24 m	8 sampling tubes Sampling tubes at 3-m intervals below the water table 3, 6, 9, 12, 15, 18, 21, 24 m	This borehole is in an important location, however there are limited sampling tubes to provide accurate information. Redrilling is recommended.
BN36	24 m	8 sampling tubes Sampling tubes at 3-m intervals below the water table 3, 6, 9, 12, 15, 18, 21, 24 m	This is a new site. Installed piezometer only in November 2013. Will provide information on the depth of the lens and impacts from boundaries and abstraction.
BN37	27 m	9 sampling tubes Sampling tubes at 3-m intervals below the water table 3, 6, 9, 12, 15, 18, 21, 24, 27 m	This is a new site recommended to be installed at a suitable location on a line between BN20 and BN4. Will provide information on the depth of the lens and peripheral edges of galleries.

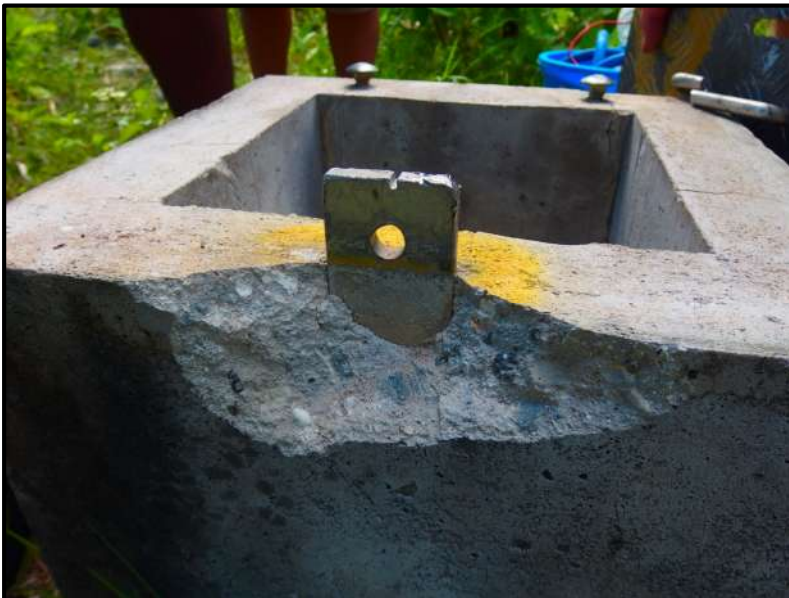
Figure 17: BN2B with the surveyed reference point identified by a notch in the locking lug of the monitoring box. (Damaged monitoring boxes were repaired as part of the project rehabilitation work).

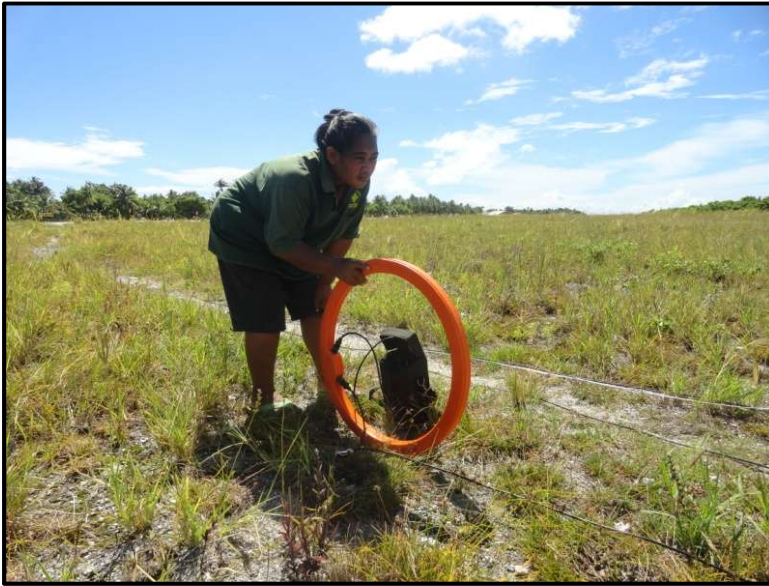
Figure 18: Ministry of Public Works and Utilities staff member undertaking EM34 surveys.

The two coils are held by operators connected by a cable of one of three defined reference lengths, 10 m, 20 m or 40 m (Figure 18). The coils are placed in the vertical or horizontal dipole position depending on the investigation design of the survey, ground conditions, and targets.

The depth of exploration depends on the separation between the transmitter coil and the receiver coil, as well as on the coil orientation (coil axis/dipole horizontal or vertical). Geological factors such as moisture content, salinity of the pore water, temperature, and composition of colloids in the ground will influence the conductivity and the success of the survey.

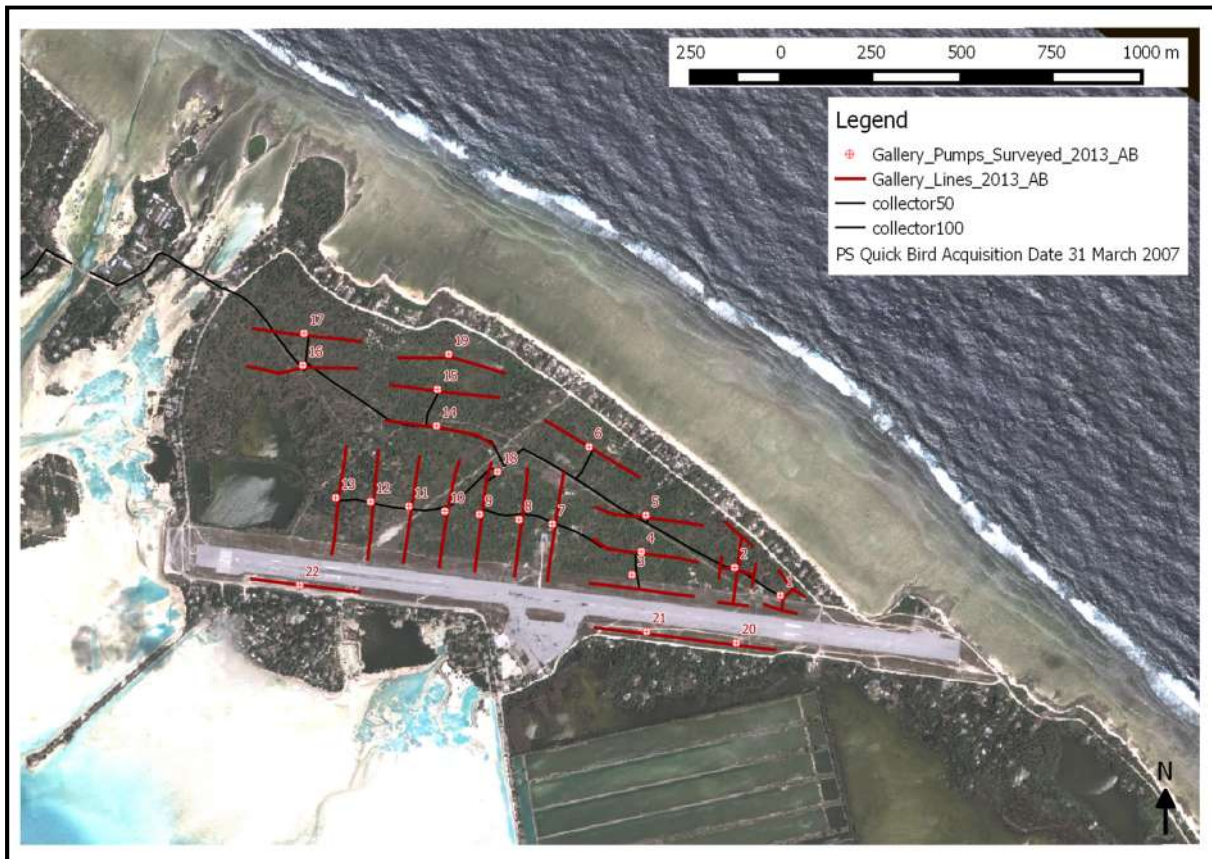
Figure 22: Gallery locations, Bonriki water reserve.

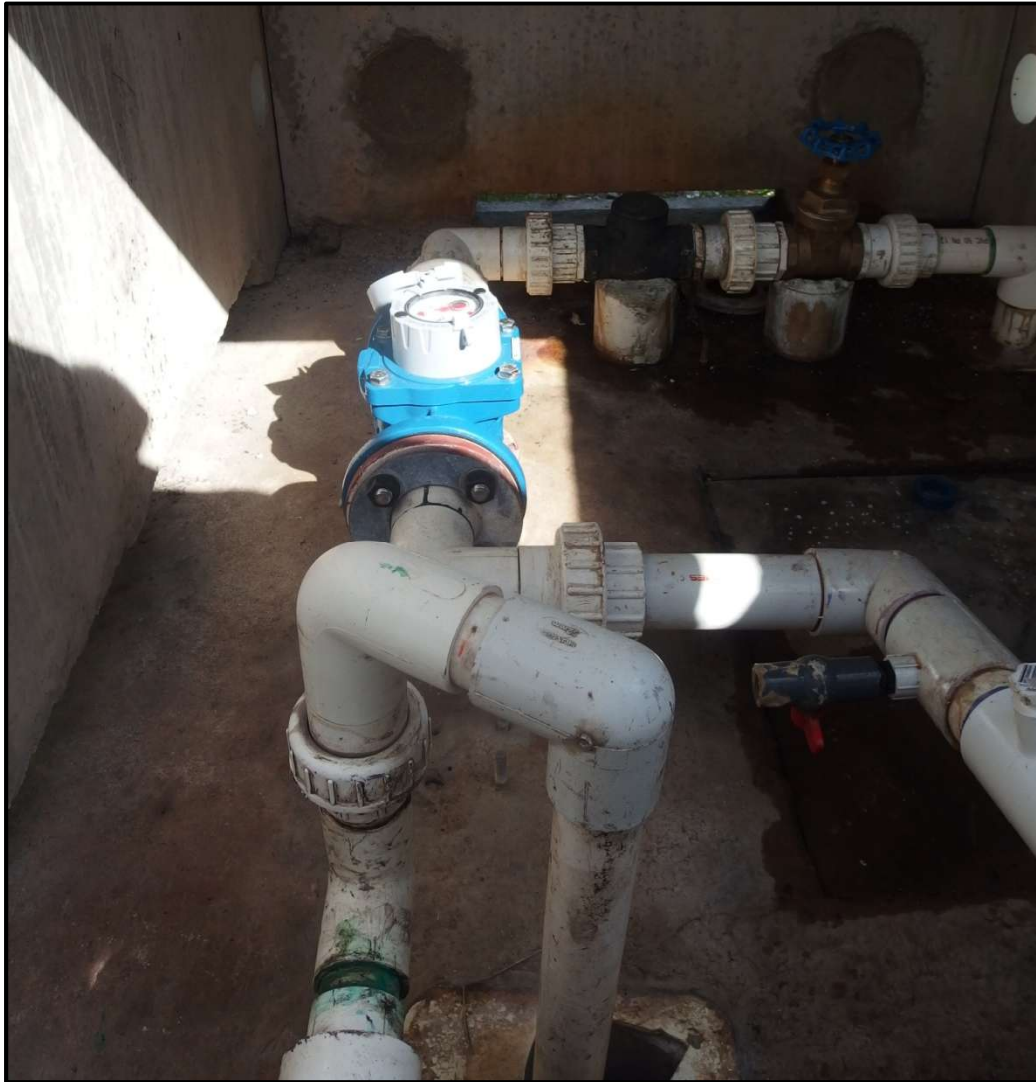
Figure 23: Replacement flow meter installed in gallery 15.

A typical setup of the replacement flow meters installed can be seen in Figure 23.

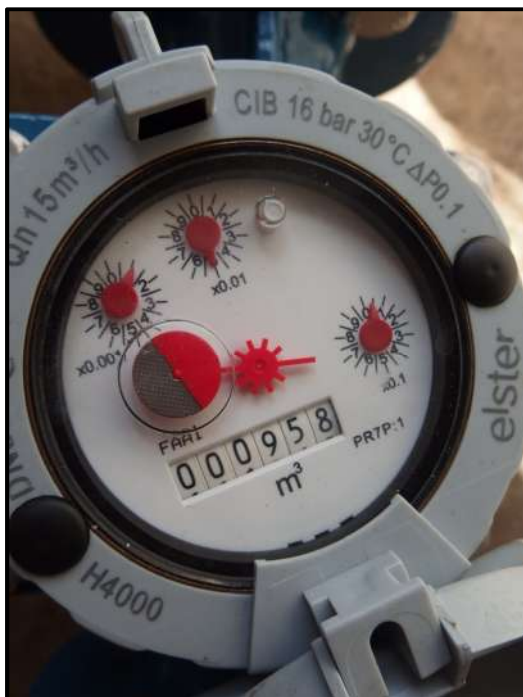
Figure 25: A 50-mm Kent Elster H400 flow meter reading 958.051 m^3 .

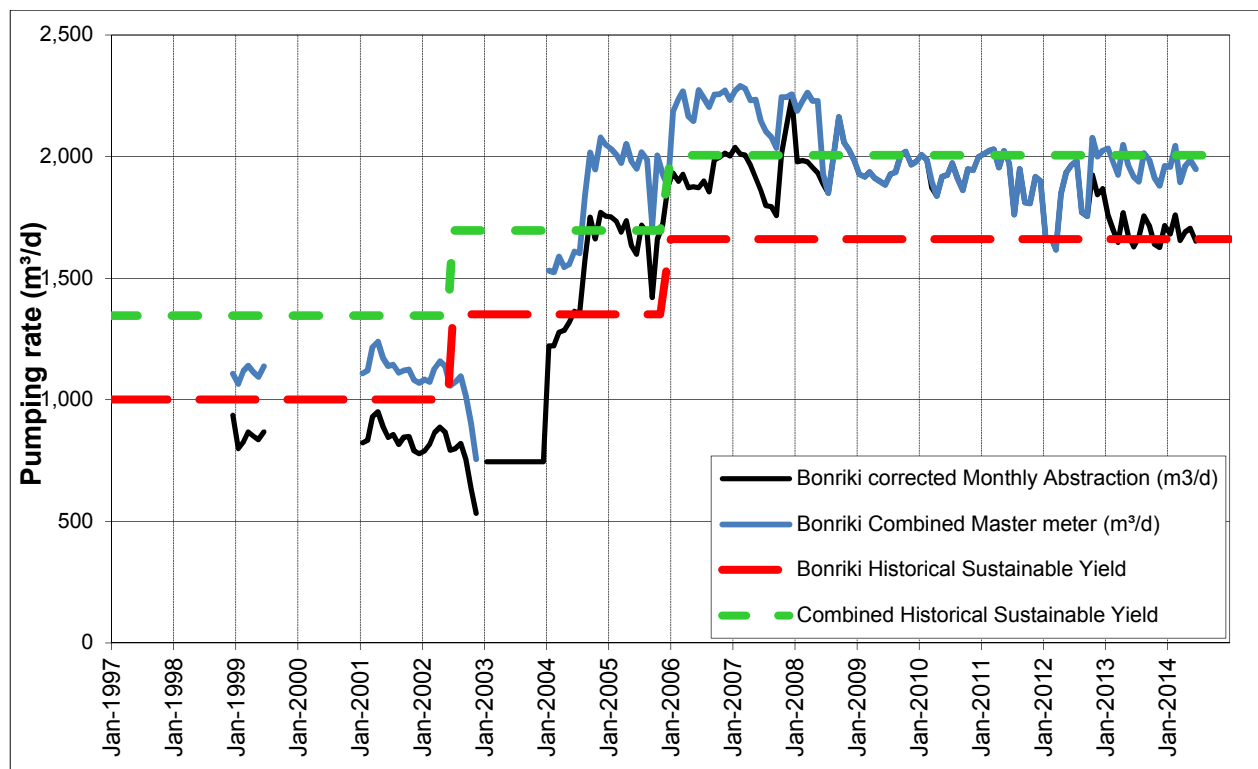
Figure 26: Historical sustainable yields for both Bonriki, and Bonriki and Buota combined compared against the abstraction for Bonriki only and combined abstraction for both Bonriki and Buota.

Figure 26 indicates the abstraction and combined sustainable yield estimates over time for the combined flow from both Bonriki and Buota water reserves. Also identified are abstraction and sustainable yield estimates for the Bonriki water reserve only over time. It is interesting to note that recent abstraction is close to the estimated sustainable yield for both Bonriki and Buota.

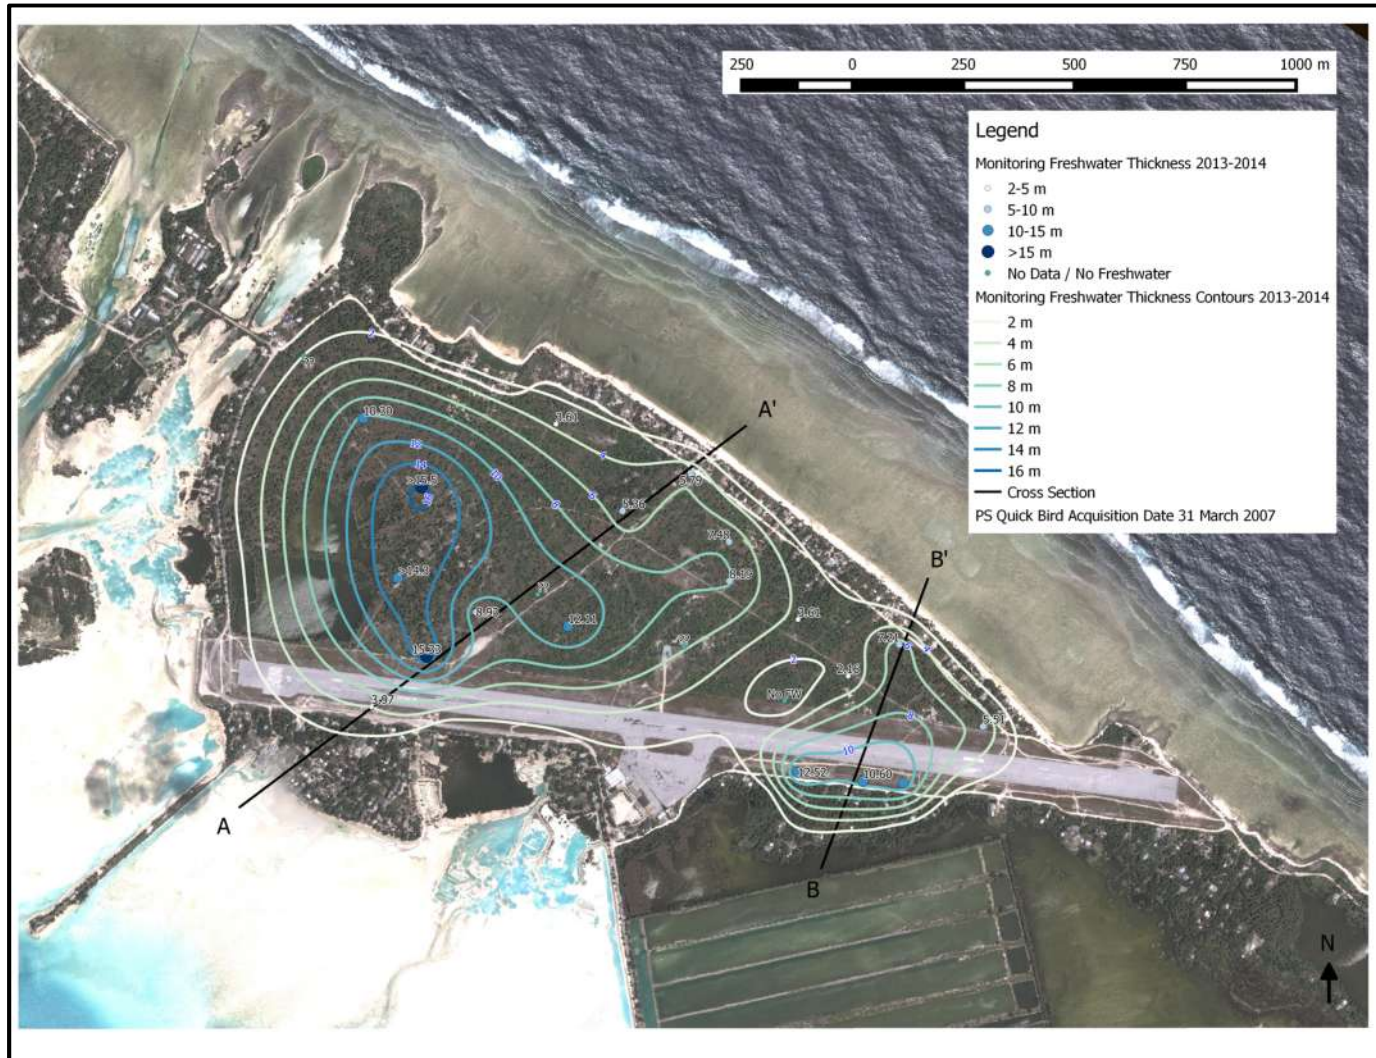
Figure 32: Contour map of the freshwater lens thickness from monitoring boreholes averaged over 2013–2014, with cross section profiles A–A' and B–B'.

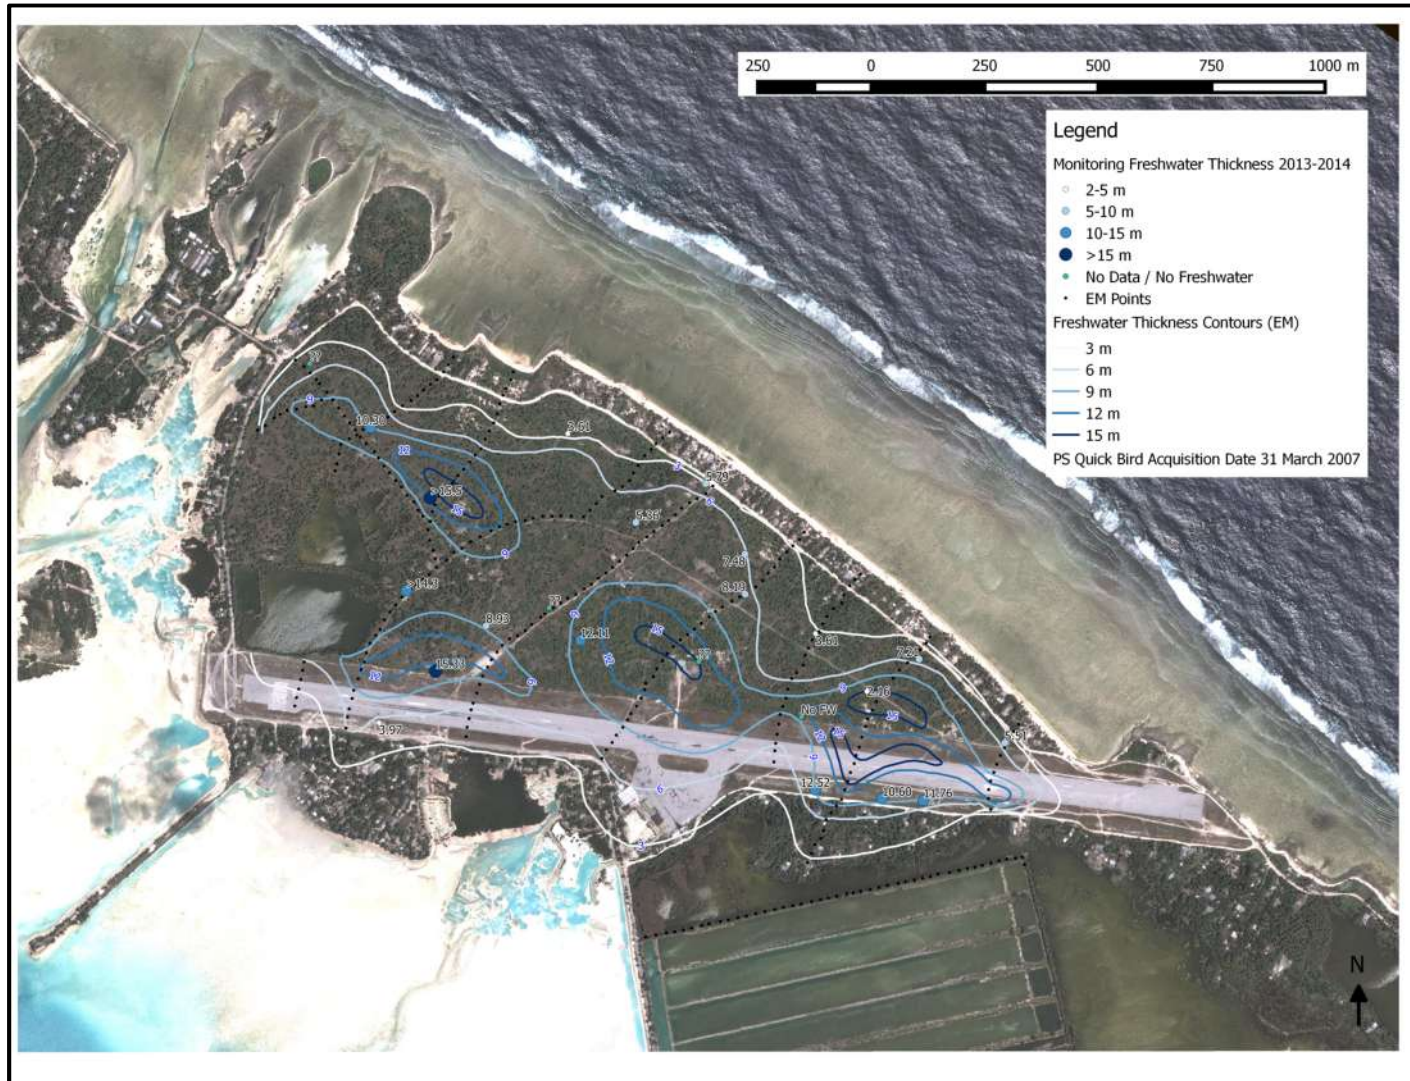
Figure 33: Contour map of freshwater lens thickness from EM34.

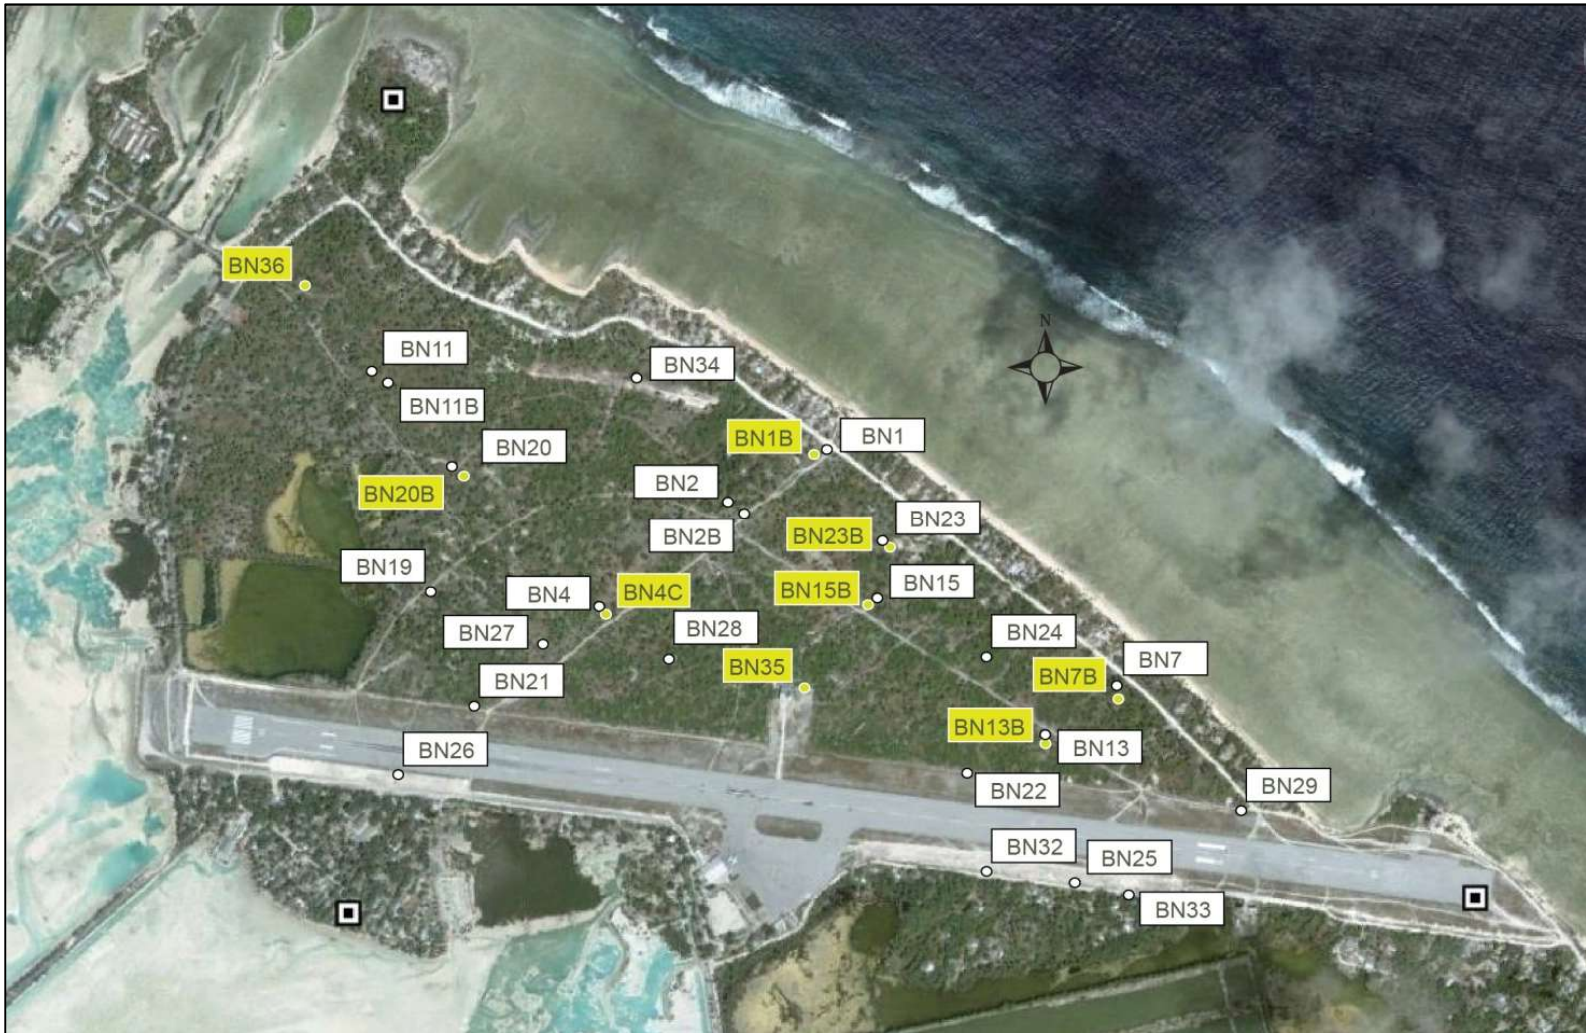
Figure A5.1: Approximate locations of Bonriki new piezometers – BN1B, BN4C, BN7B, BN13B, BN15B, BN20B, BN23B, BN35 and BN36.

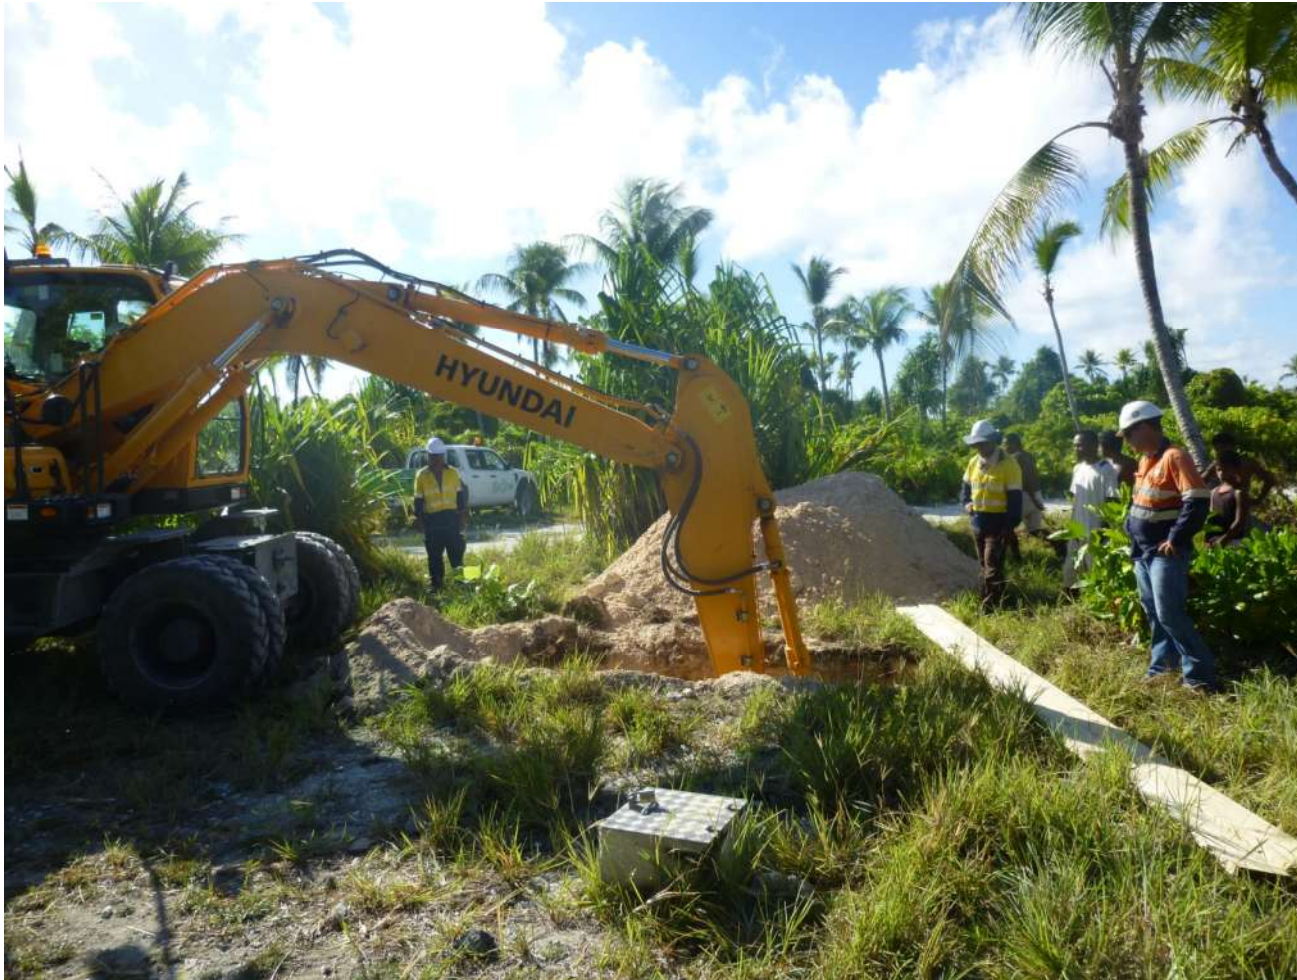
Figure A5.24: Excavator digging piezometer pit – BN1.

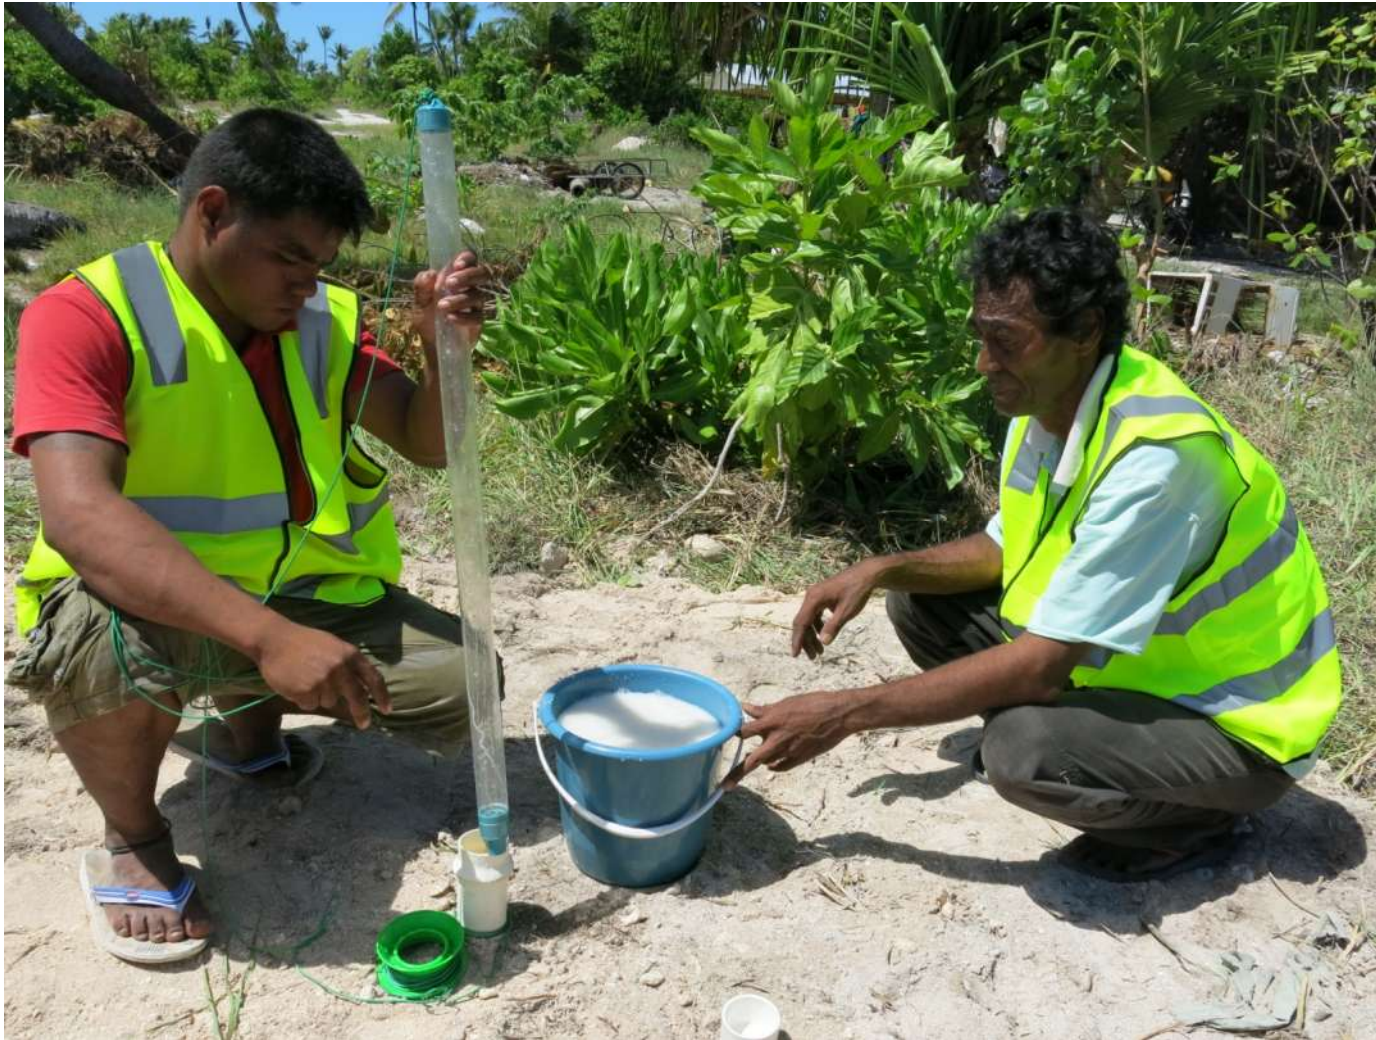
Figure A5.29: Bailing of piezometer to clear silt and develop well until clear sample is obtained – BN1.

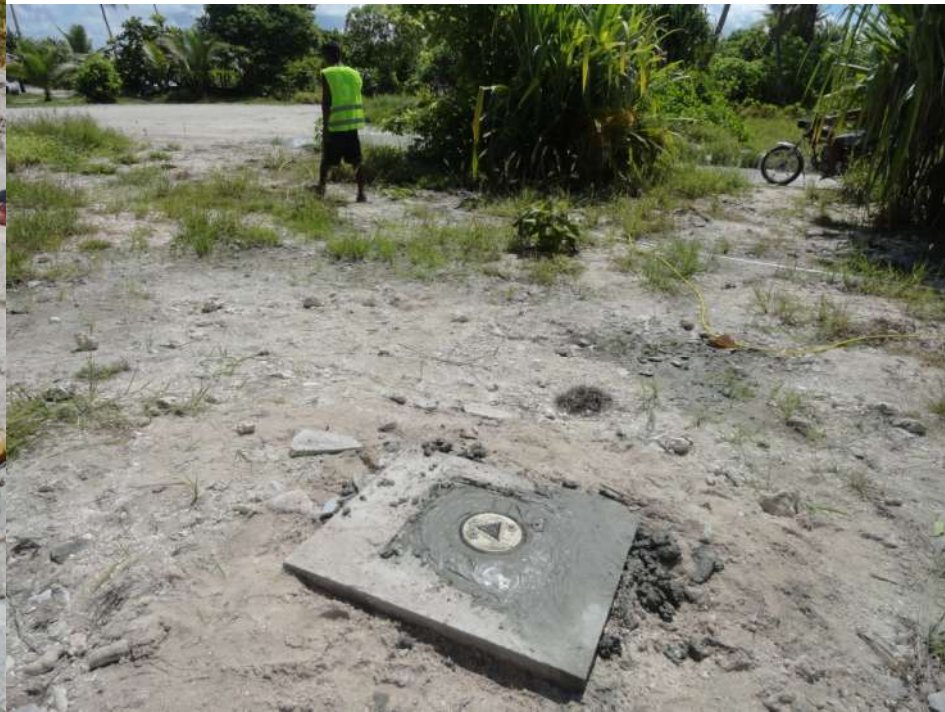
Figure A5.31: Finished borehole cover – BN1.

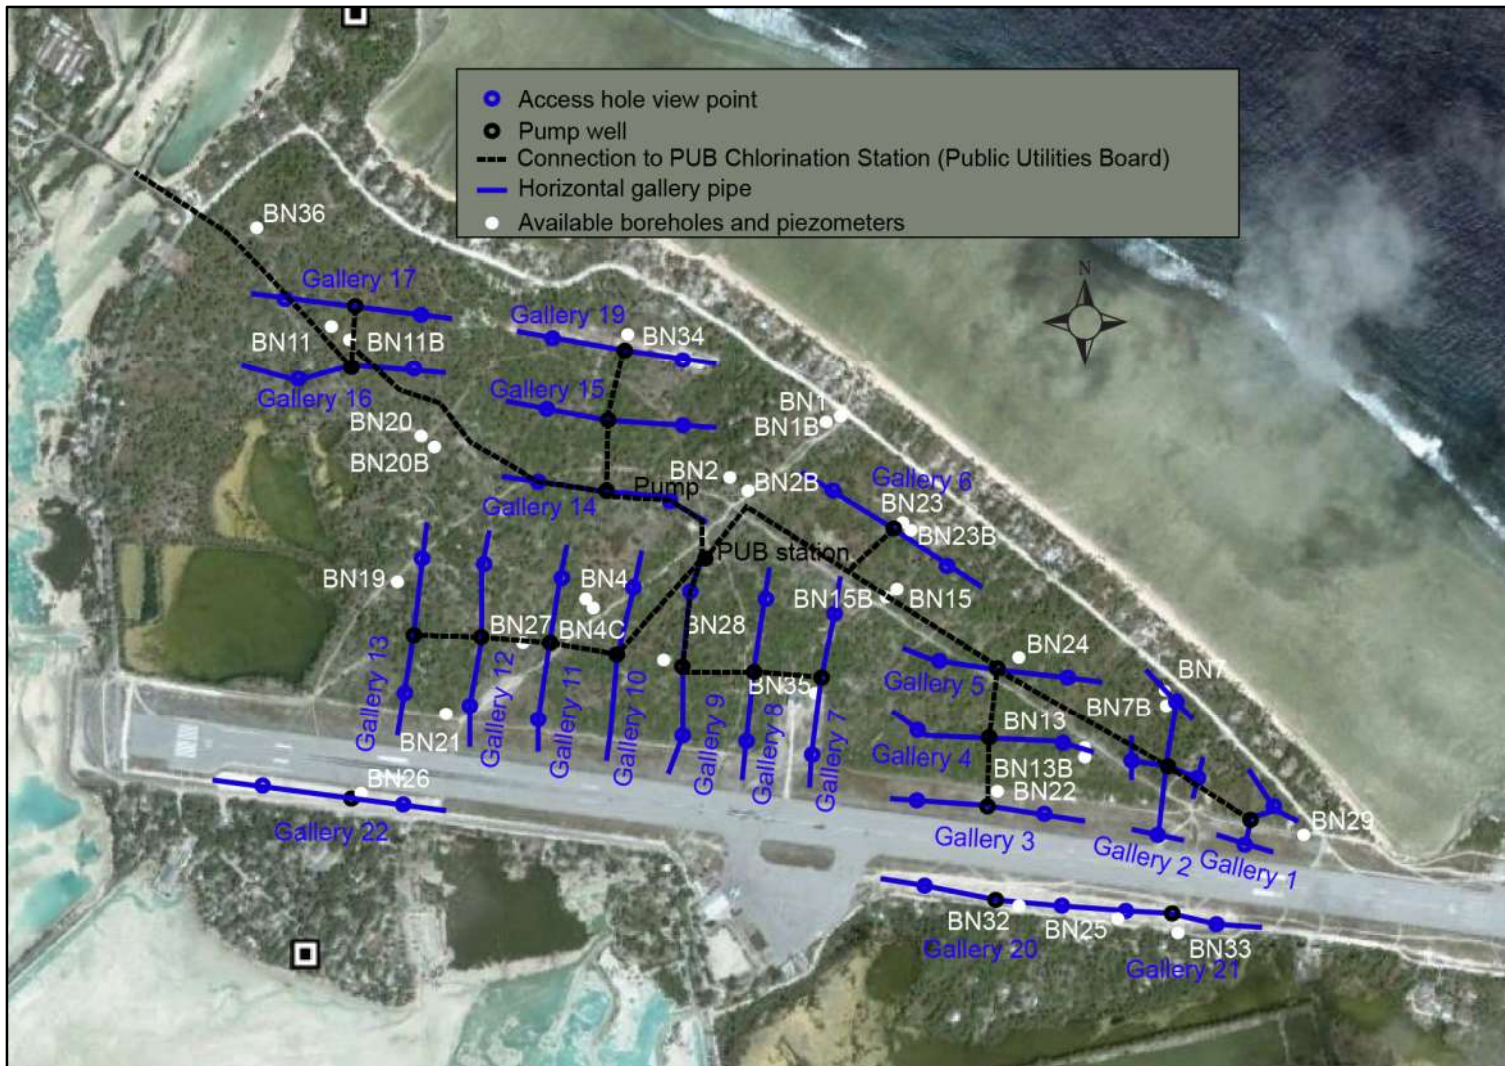
Figure A6.1: Locations of Bonriki monitoring bores and infiltration galleries.

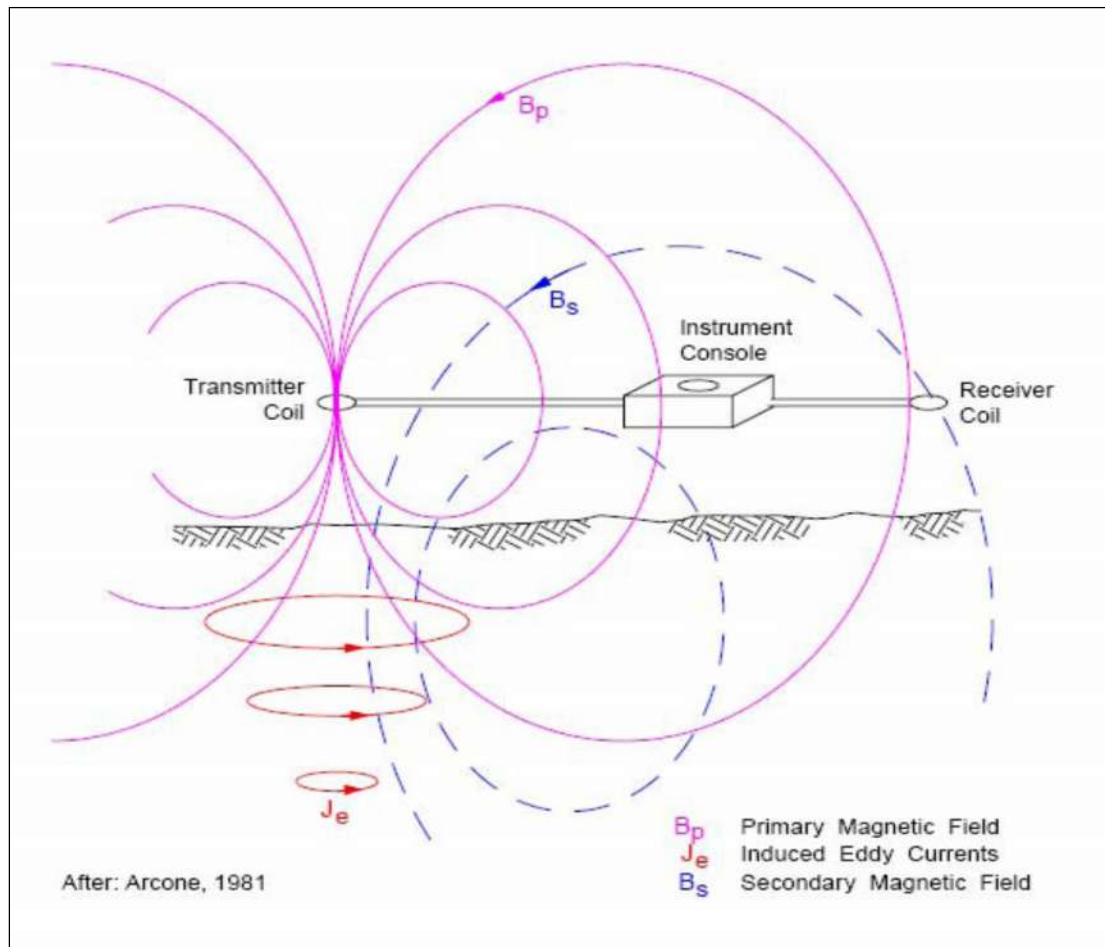
Figure A7.1: EM principle of operation (NGA 2000).

This equipment exhibits a number of features that enhance its use for groundwater surveys, including portability and ruggedness, survey productivity, good resolution, reliable operation over a wide range of air temperatures, linearity between meter reading and ground conductivity over a large range of ground conductivity values, and relatively simple interpretative techniques for ground with conductivity stratification.
