Bonriki Inundation Vulnerability Assessment

Groundwater Field Investigations
Bonriki Water Reserve, South Tarawa, Kiribati

SPC Technical Report SPC00009

April 2015

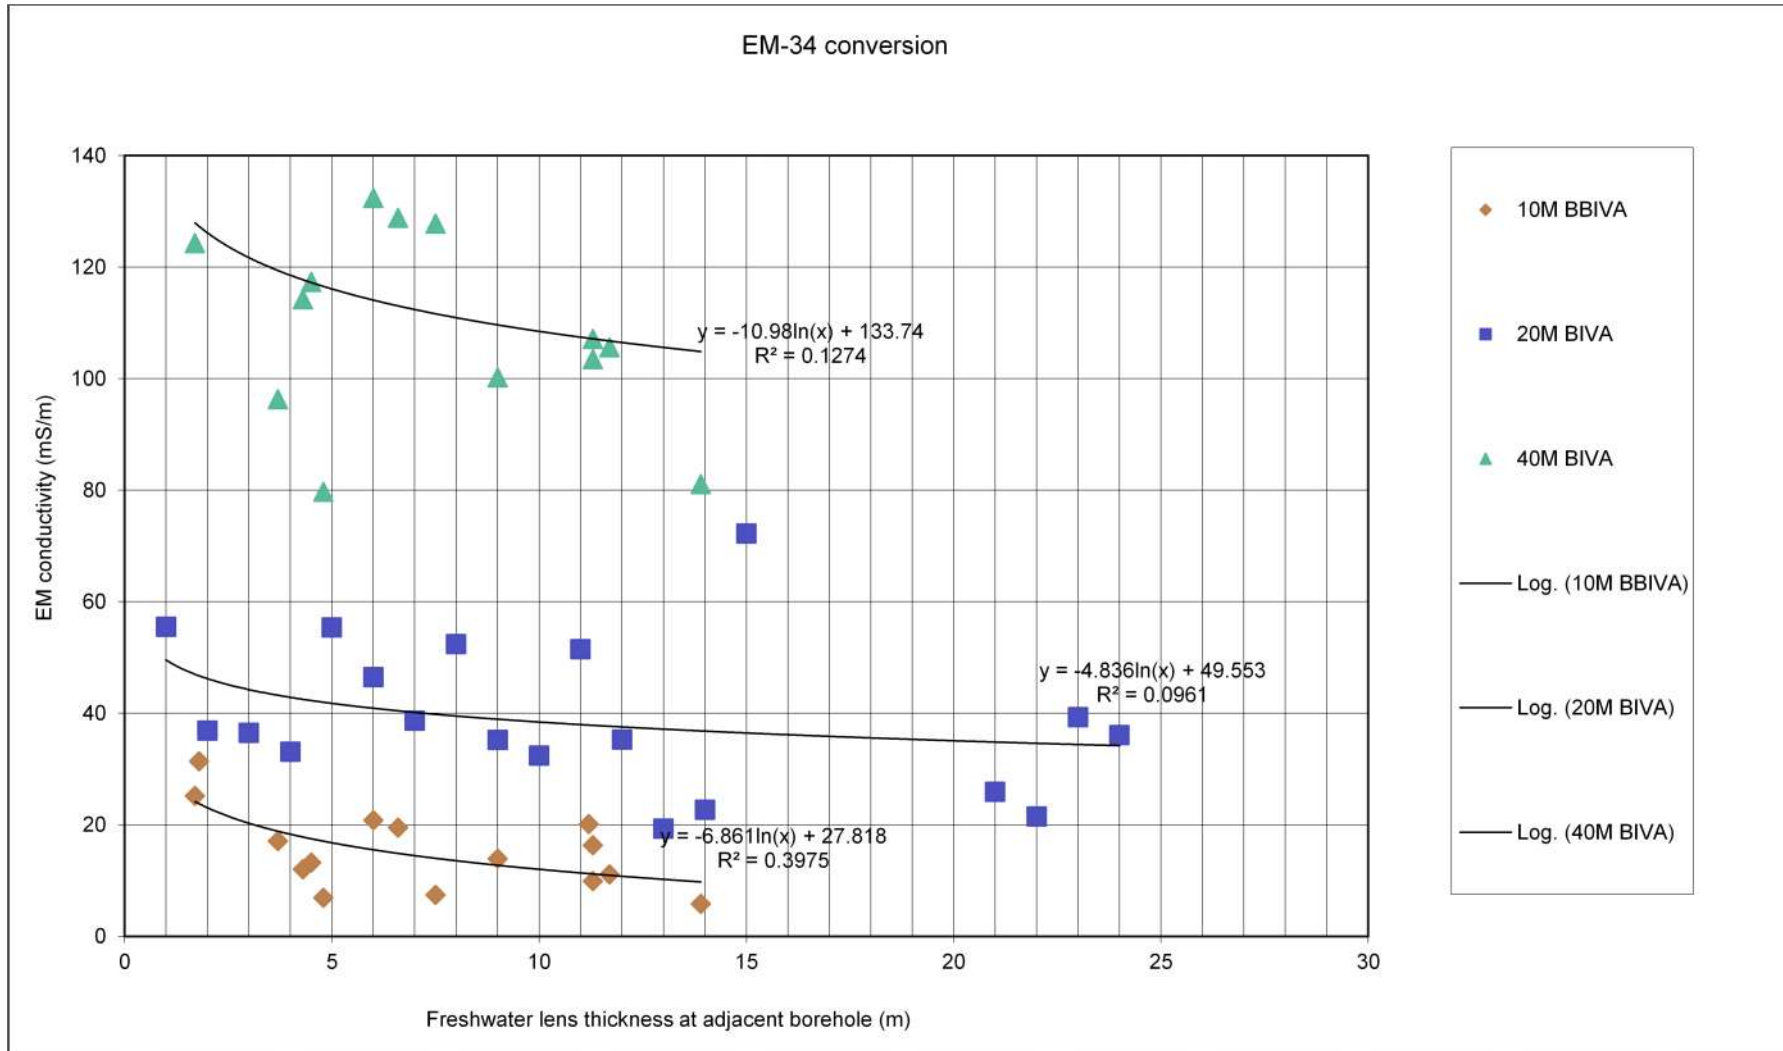
Figure A7.2: Calibration data used to estimate the freshwater lens thickness for 10 m, 20 m, and 40 m separations.

Figure 7.2 presents the logarithmic curves and equations which are used to calculate freshwater thickness. The 10 m spacing measurements, made in February 2014, provides the best fit, when compared to 20 m spacing and 40 m spacing measurements. Therefore, the 10 m spacing log equation was used for estimating freshwater lens thickness.

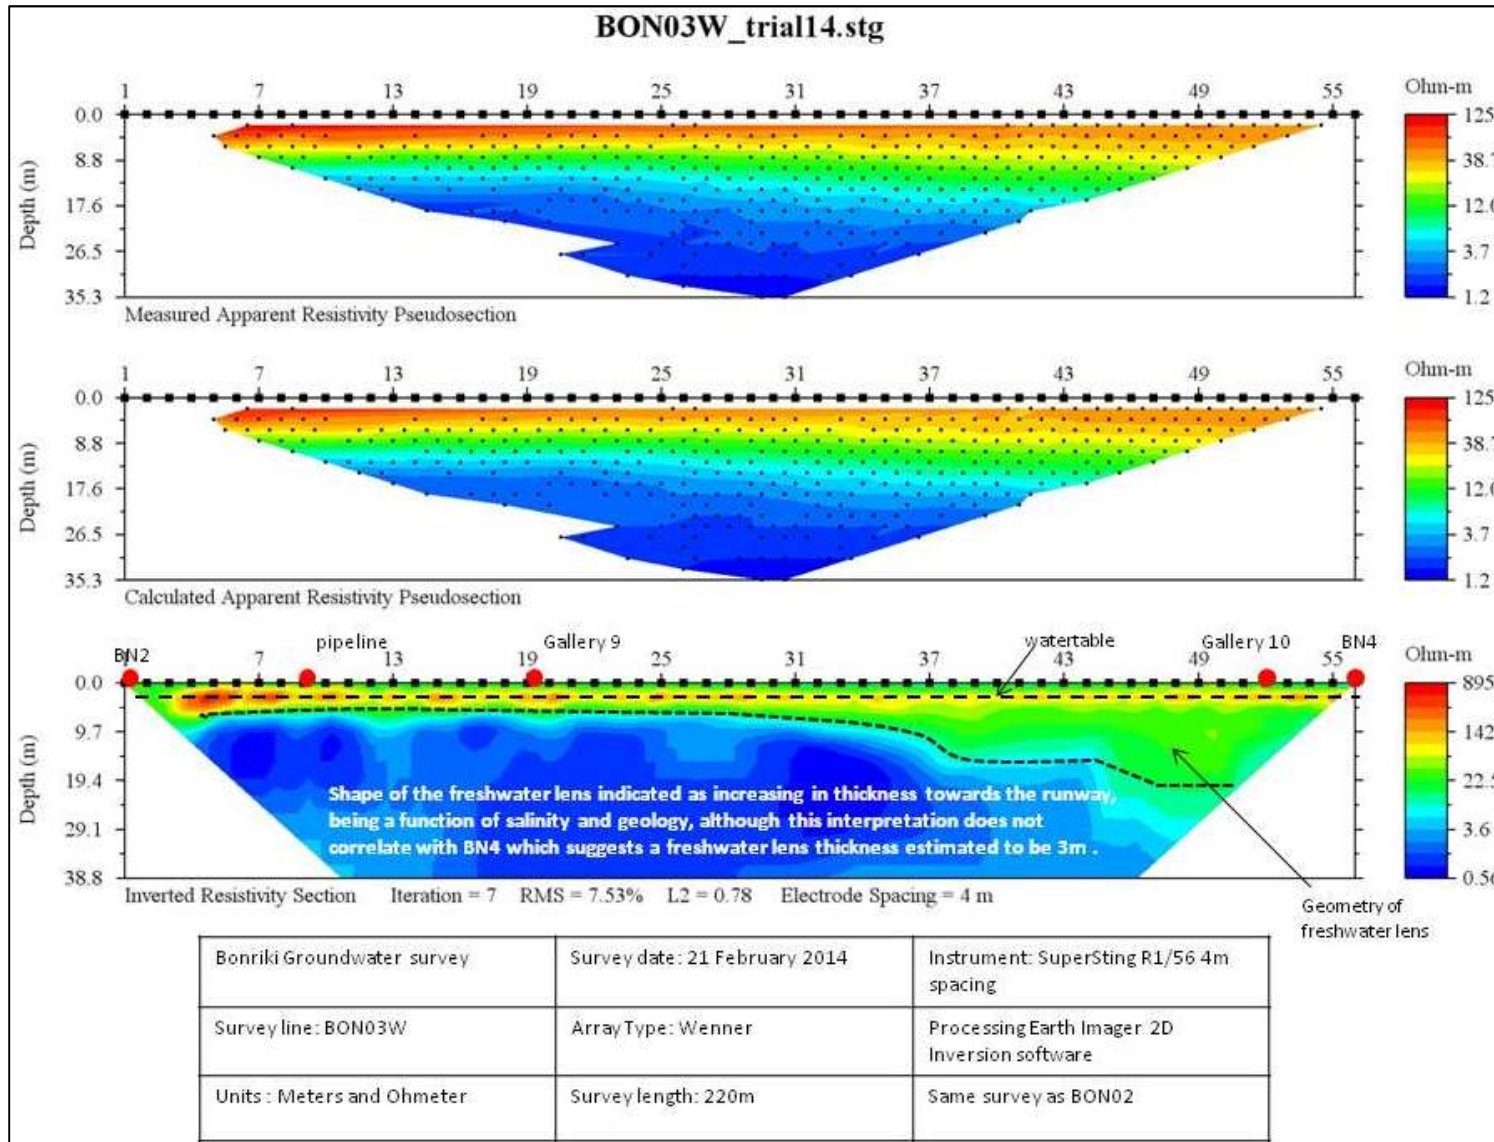
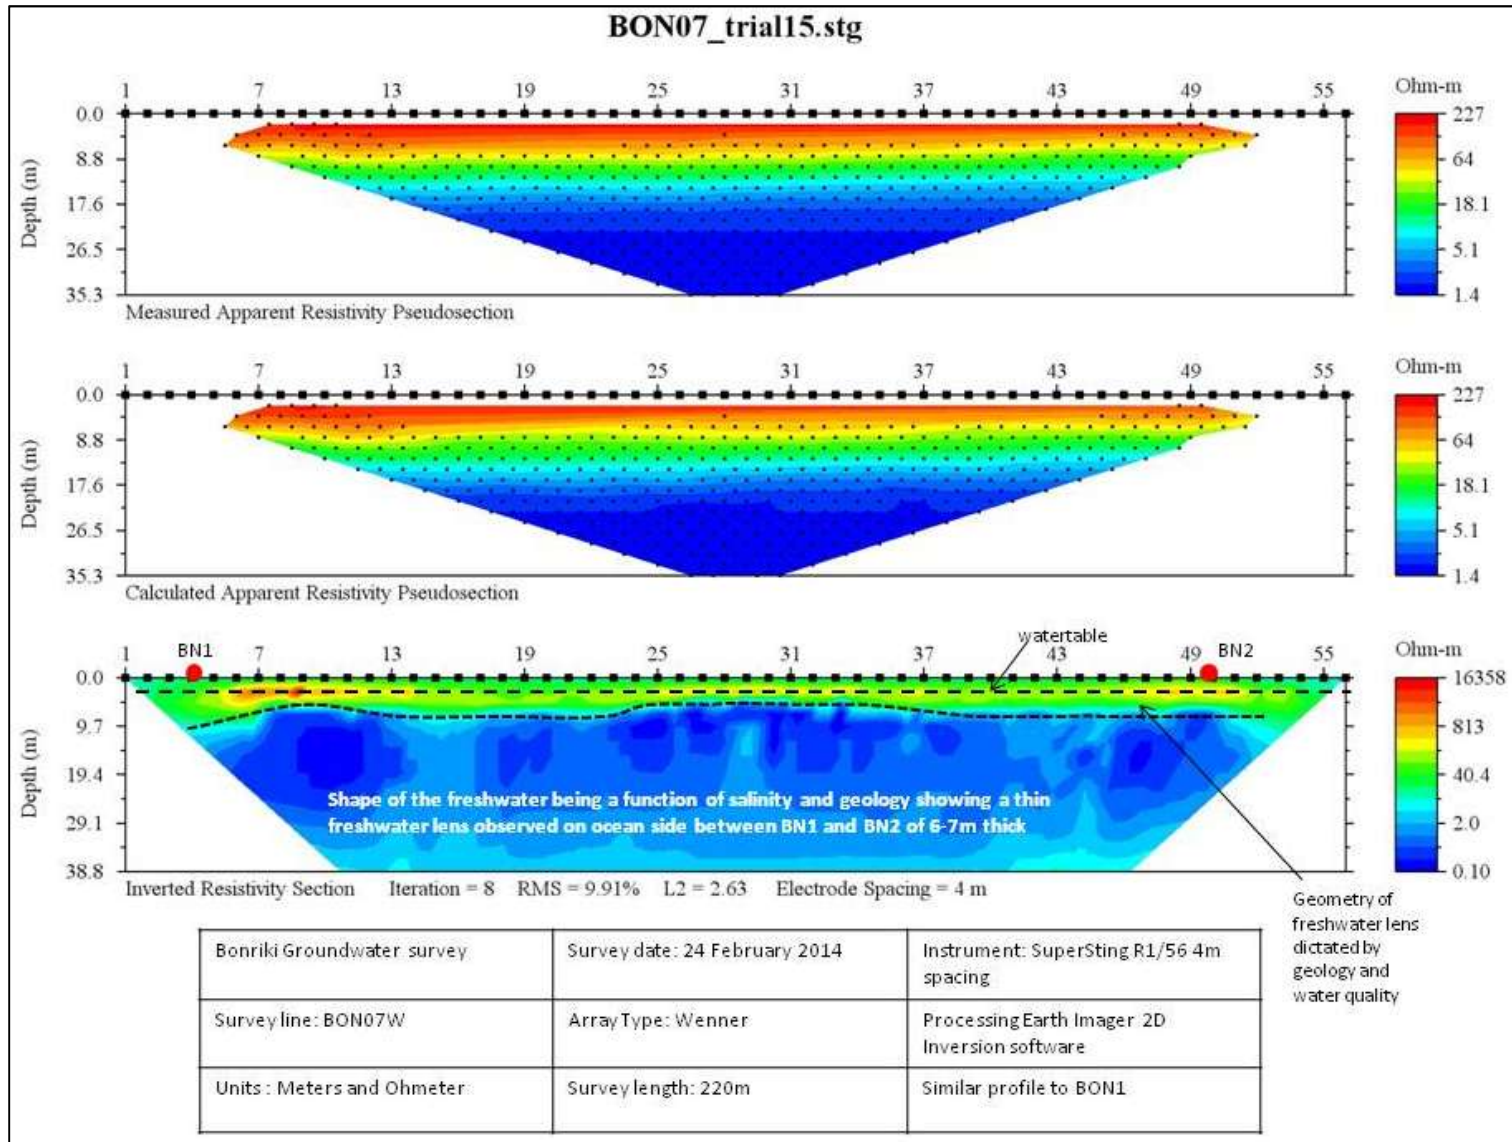
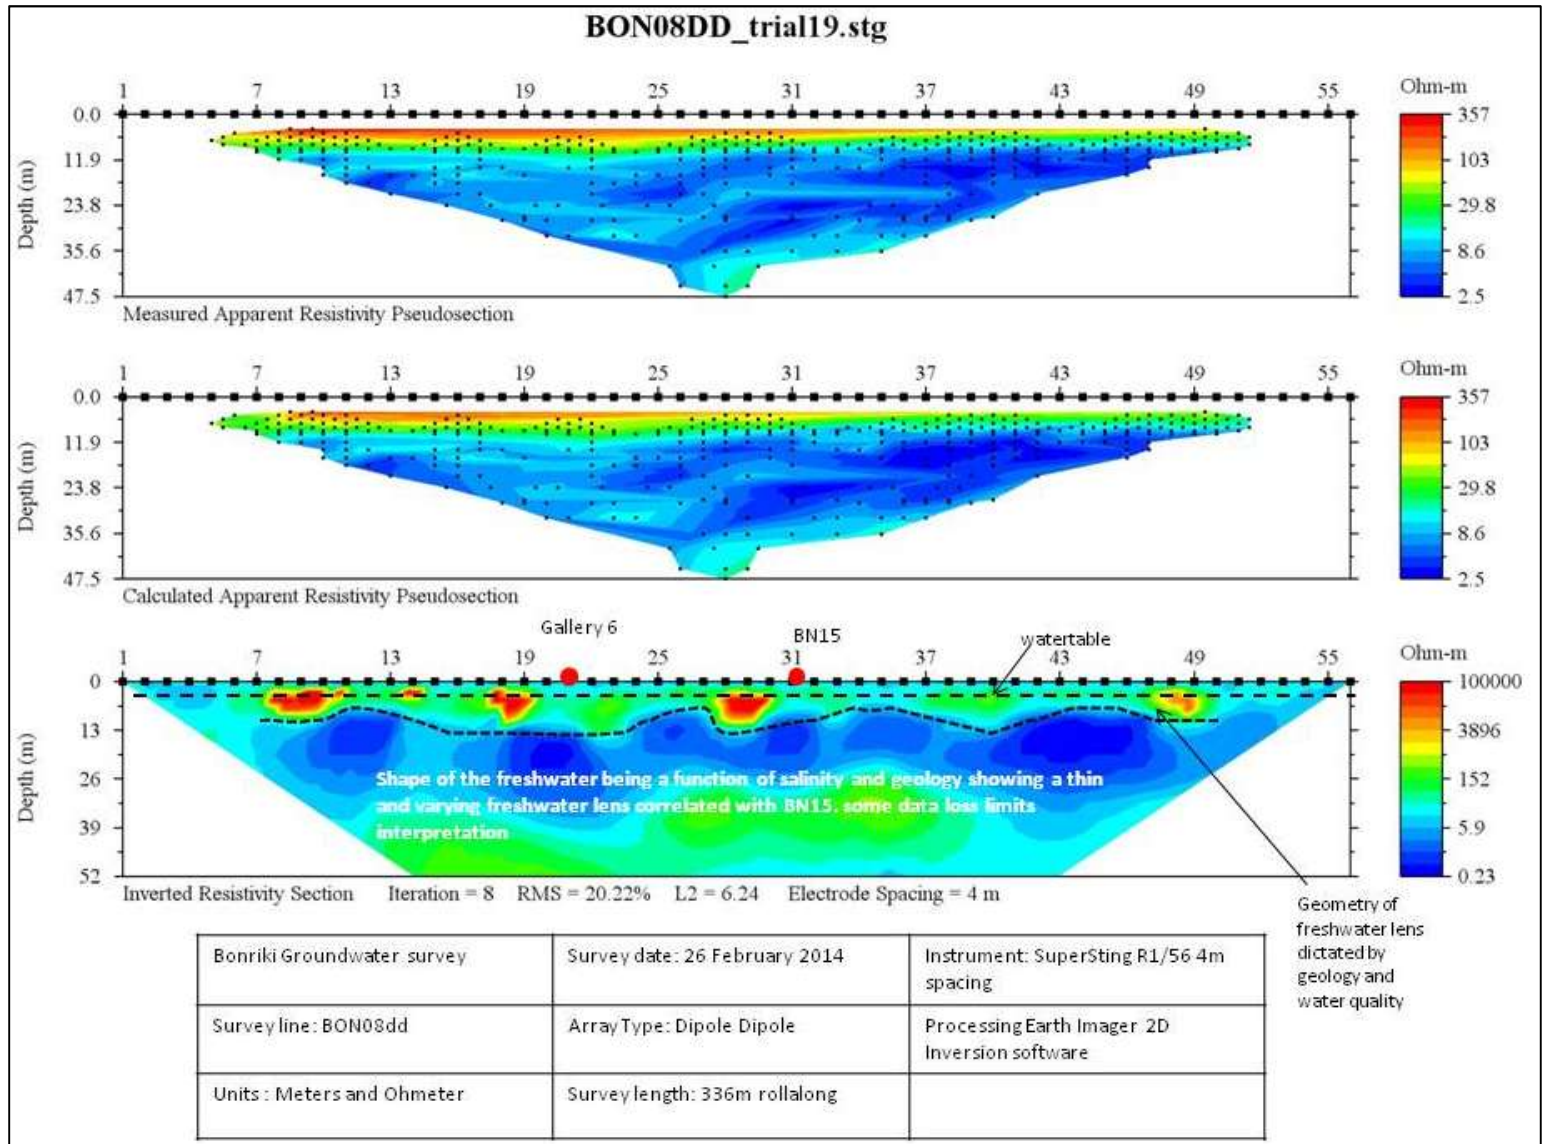
Figure A8.3: Survey line BON01.

Figure A8.4: Survey line BON02.

Figure A8.5: Survey line BON03W.

Figure A8.6: Survey line BON04.

Figure A8.7: Survey line BON05W.

Figure A8.8: Survey line BON06W.

Figure A8.9: Survey line BON07.

Figure A8.10: Survey line BON08DD.

Figure A8.11: Survey line BON08W.

Figure A8.12: Survey line BON09.

Figure A8.13: Survey line BON10.

Figure A8.14: Survey line BON11.

Figure A8.15: Survey line BON12.

Figure A8.16: Survey line BON13.

Figure A8.17: Survey line BON14.

Figure A8.18: Survey line BON15.

Figure A8.19: Survey line BON16.

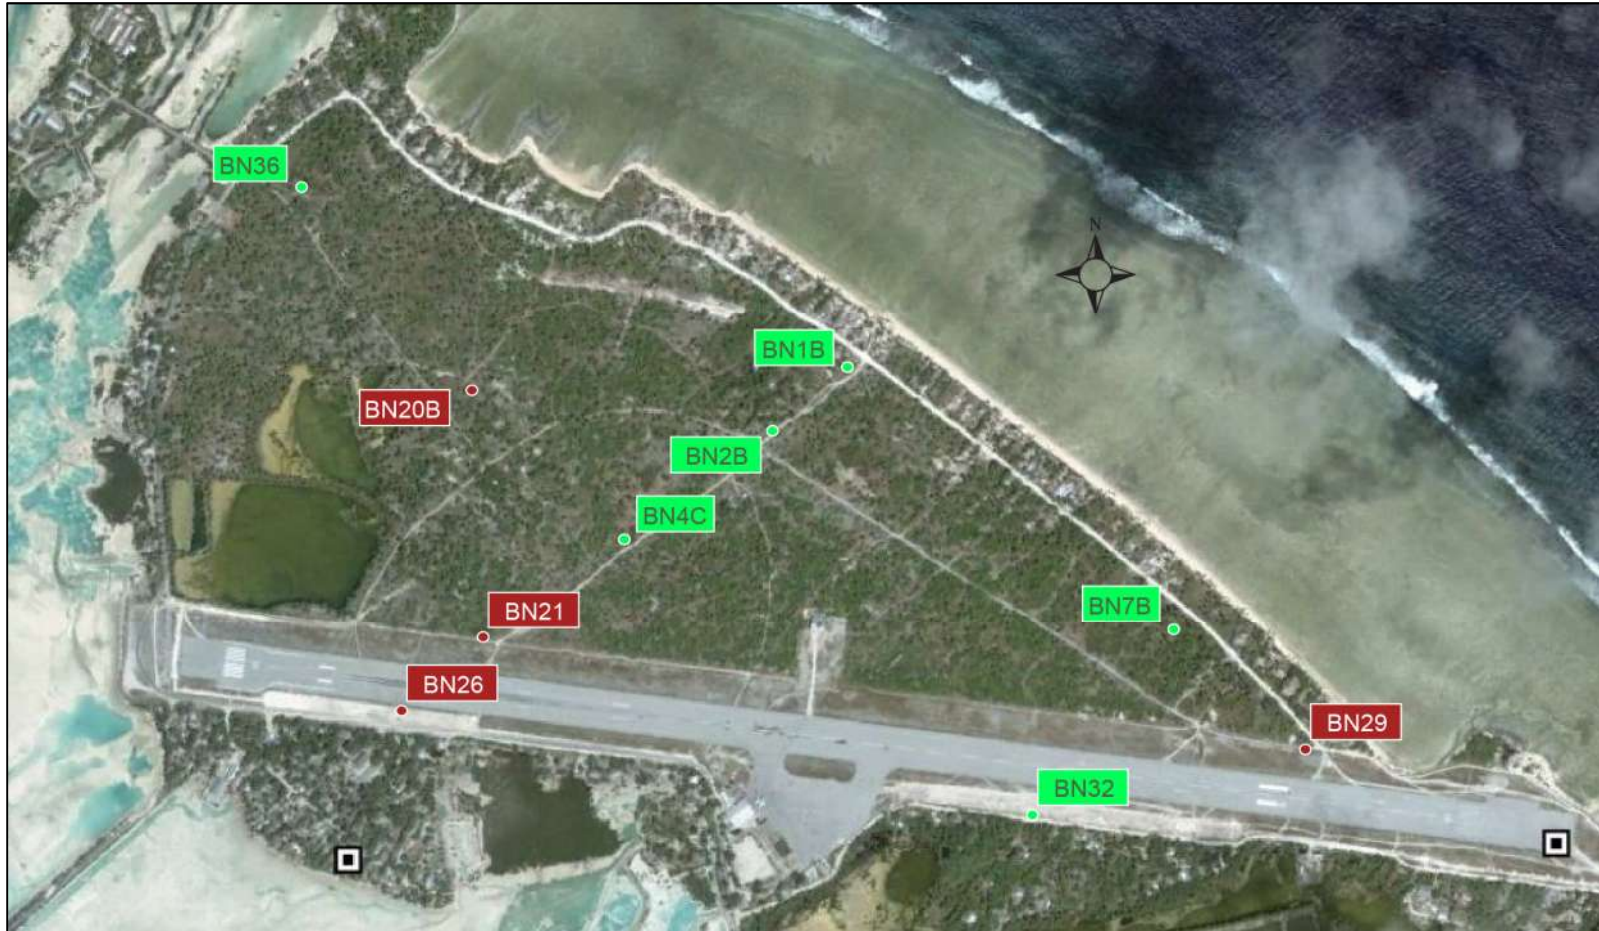
Figure A10.1: Location of the 10 CTD divers (divers denoted in green installed Nov 2013–March 2014; divers denoted in red installed Nov 2013–June 2014). The barometer diver was located in BN26.

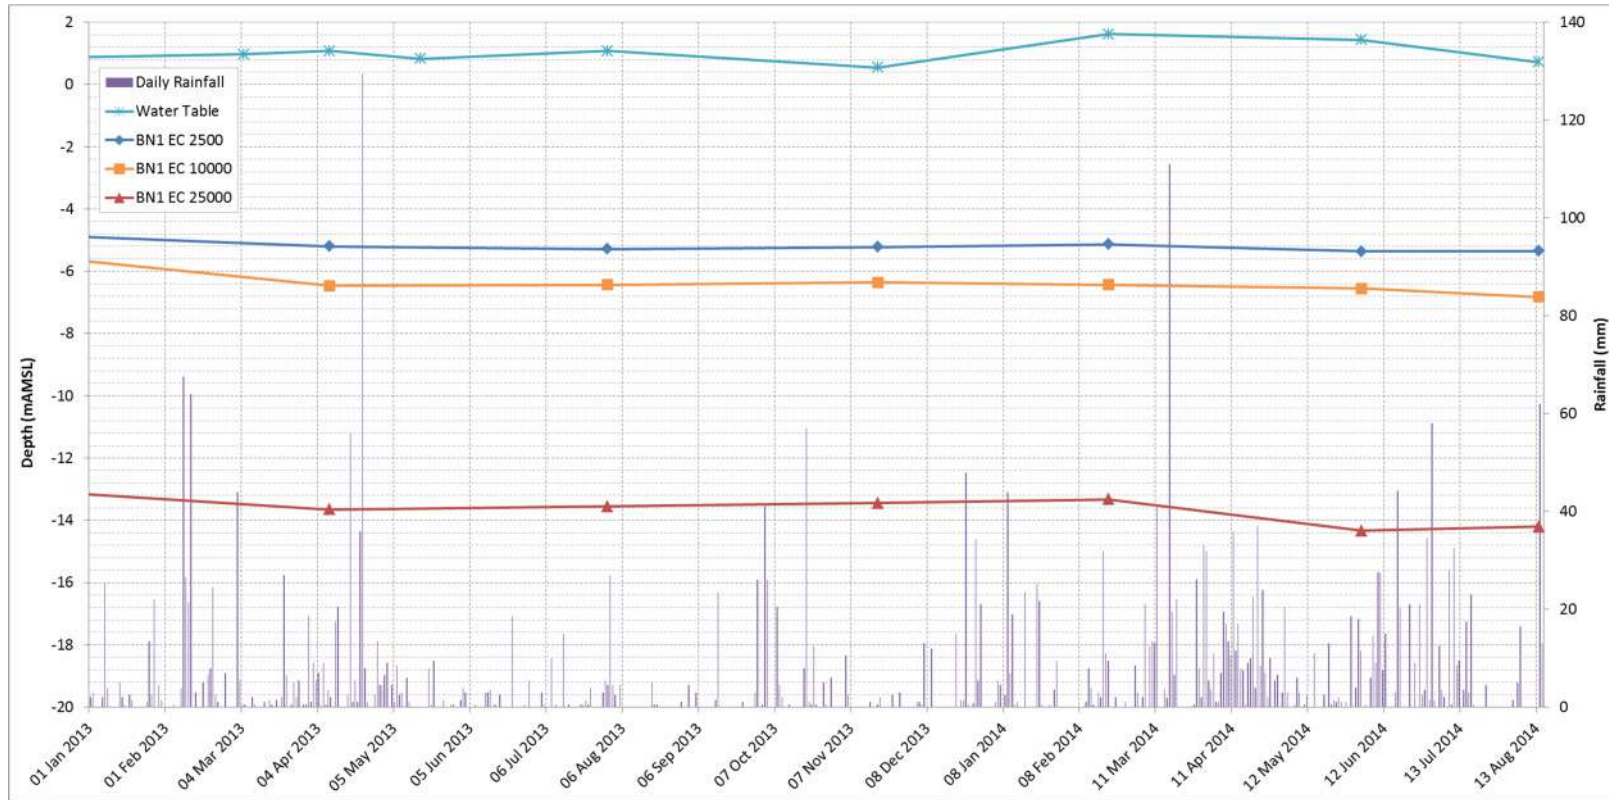
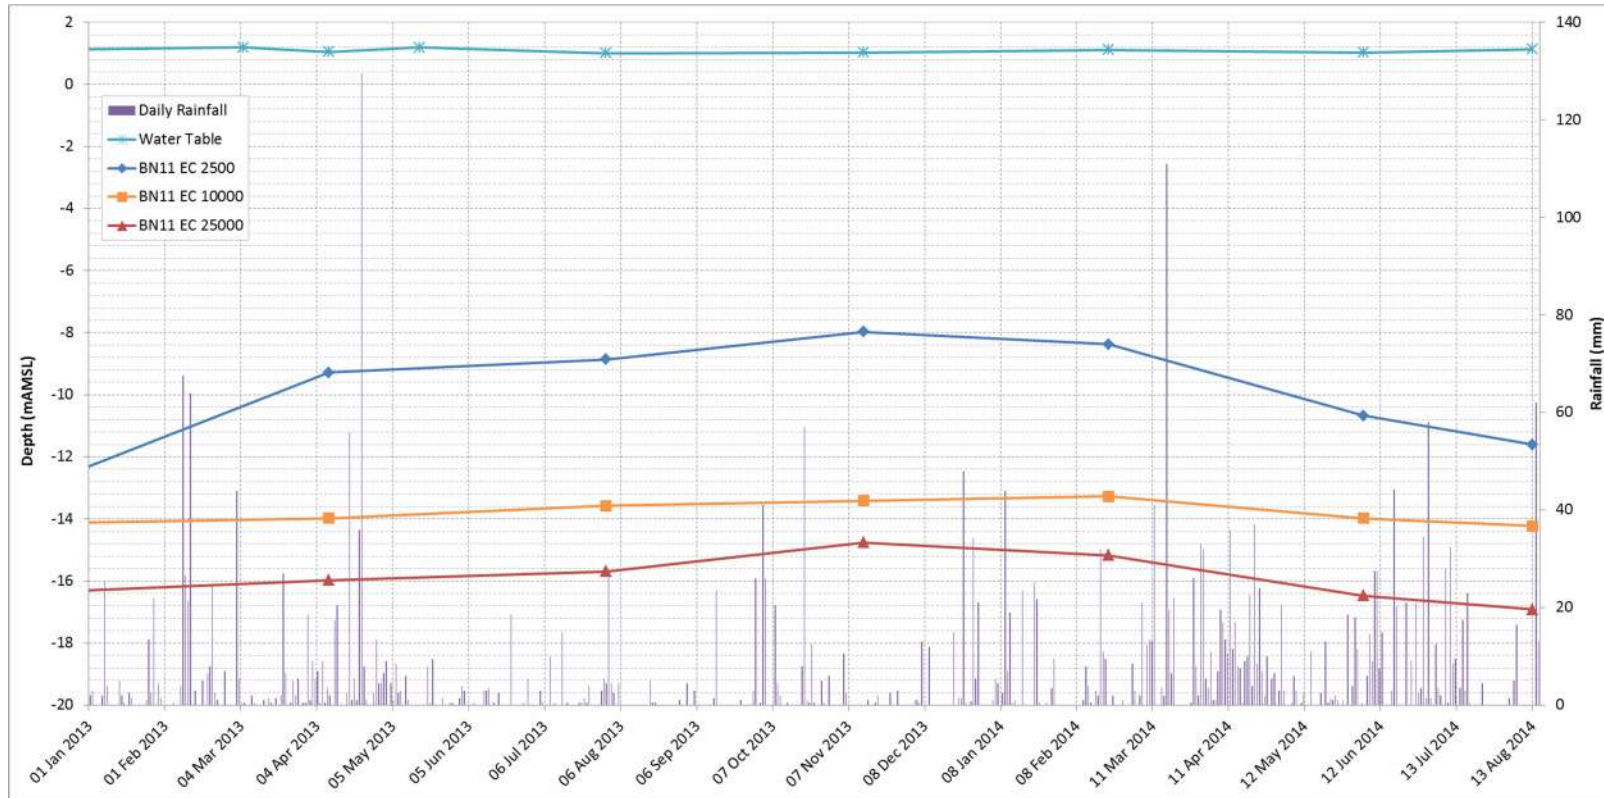
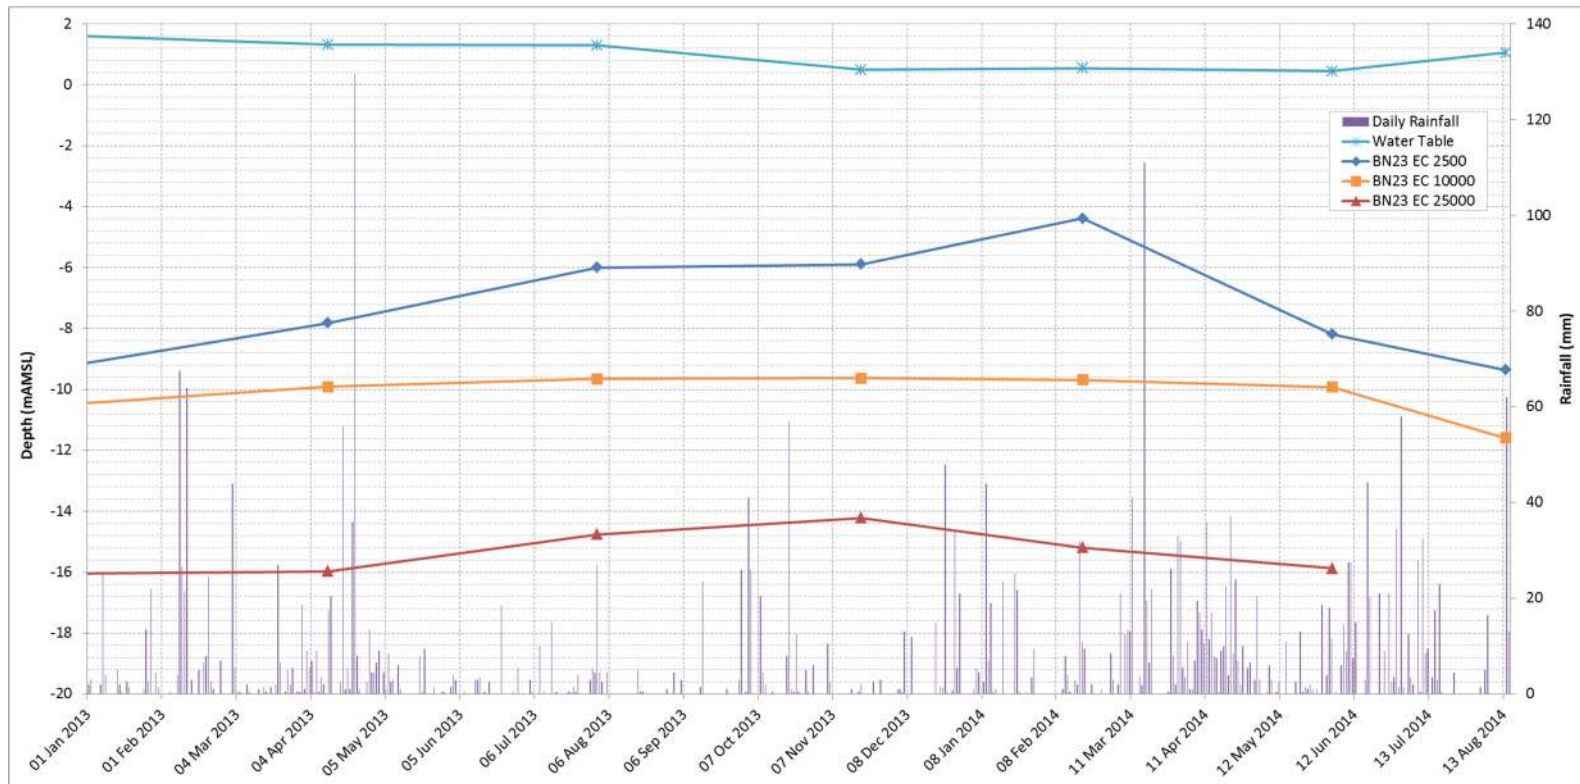
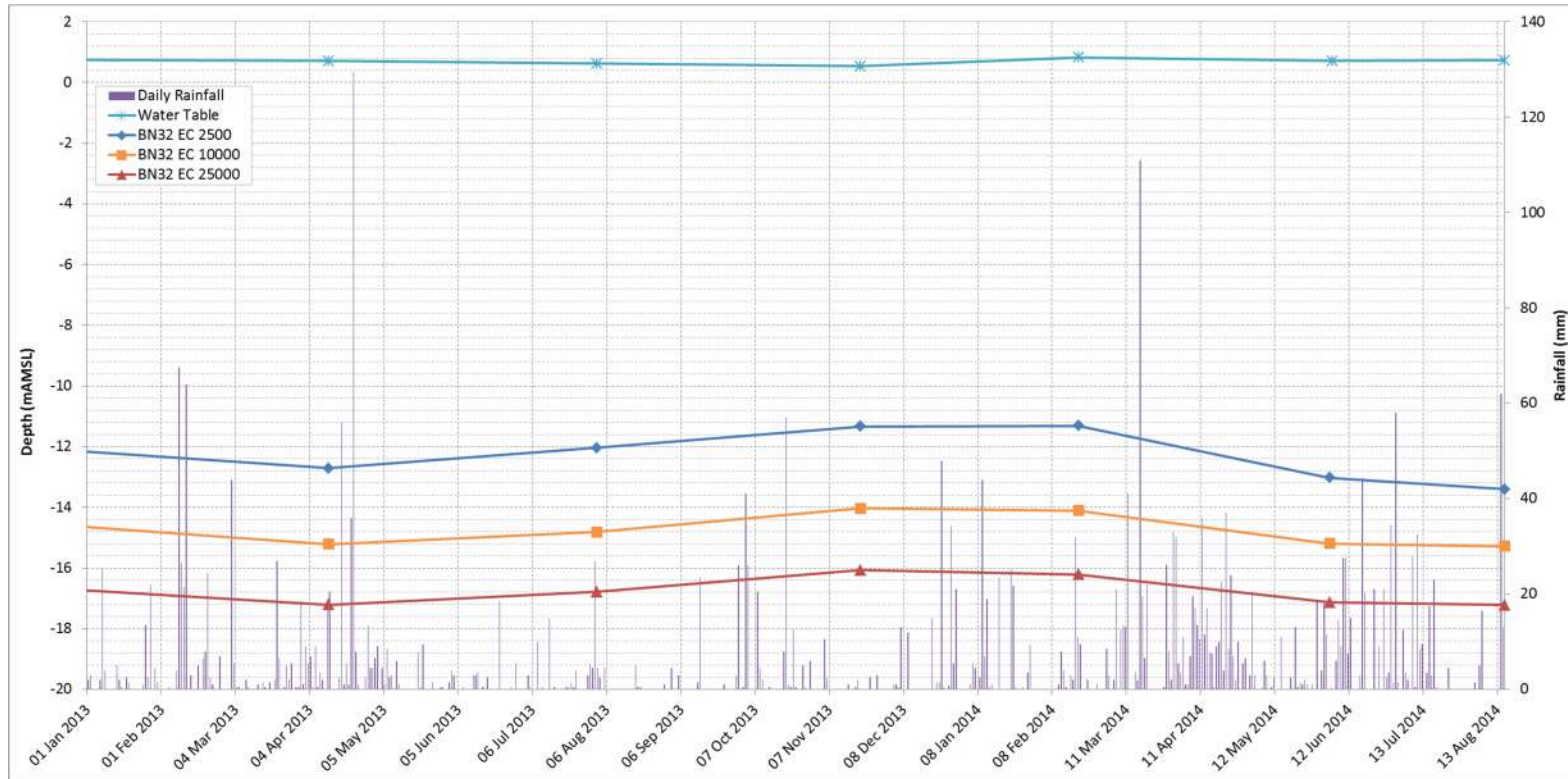
Figure A12.9: Recent salinity variations at monitoring location BN1.

Figure A12.10: Recent salinity variations at monitoring location BN11.

Figure A12.17: Recent salinity variations at monitoring location BN23.

Figure A12.22: Recent salinity variations at monitoring location BN32.

Figure A12.26: Recent salinity variations at monitoring location BN4.
