# Bonriki Inundation Vulnerability Assessment

## Shoreline Change Mapping

SPC Technical Report SPC00006

May 2015

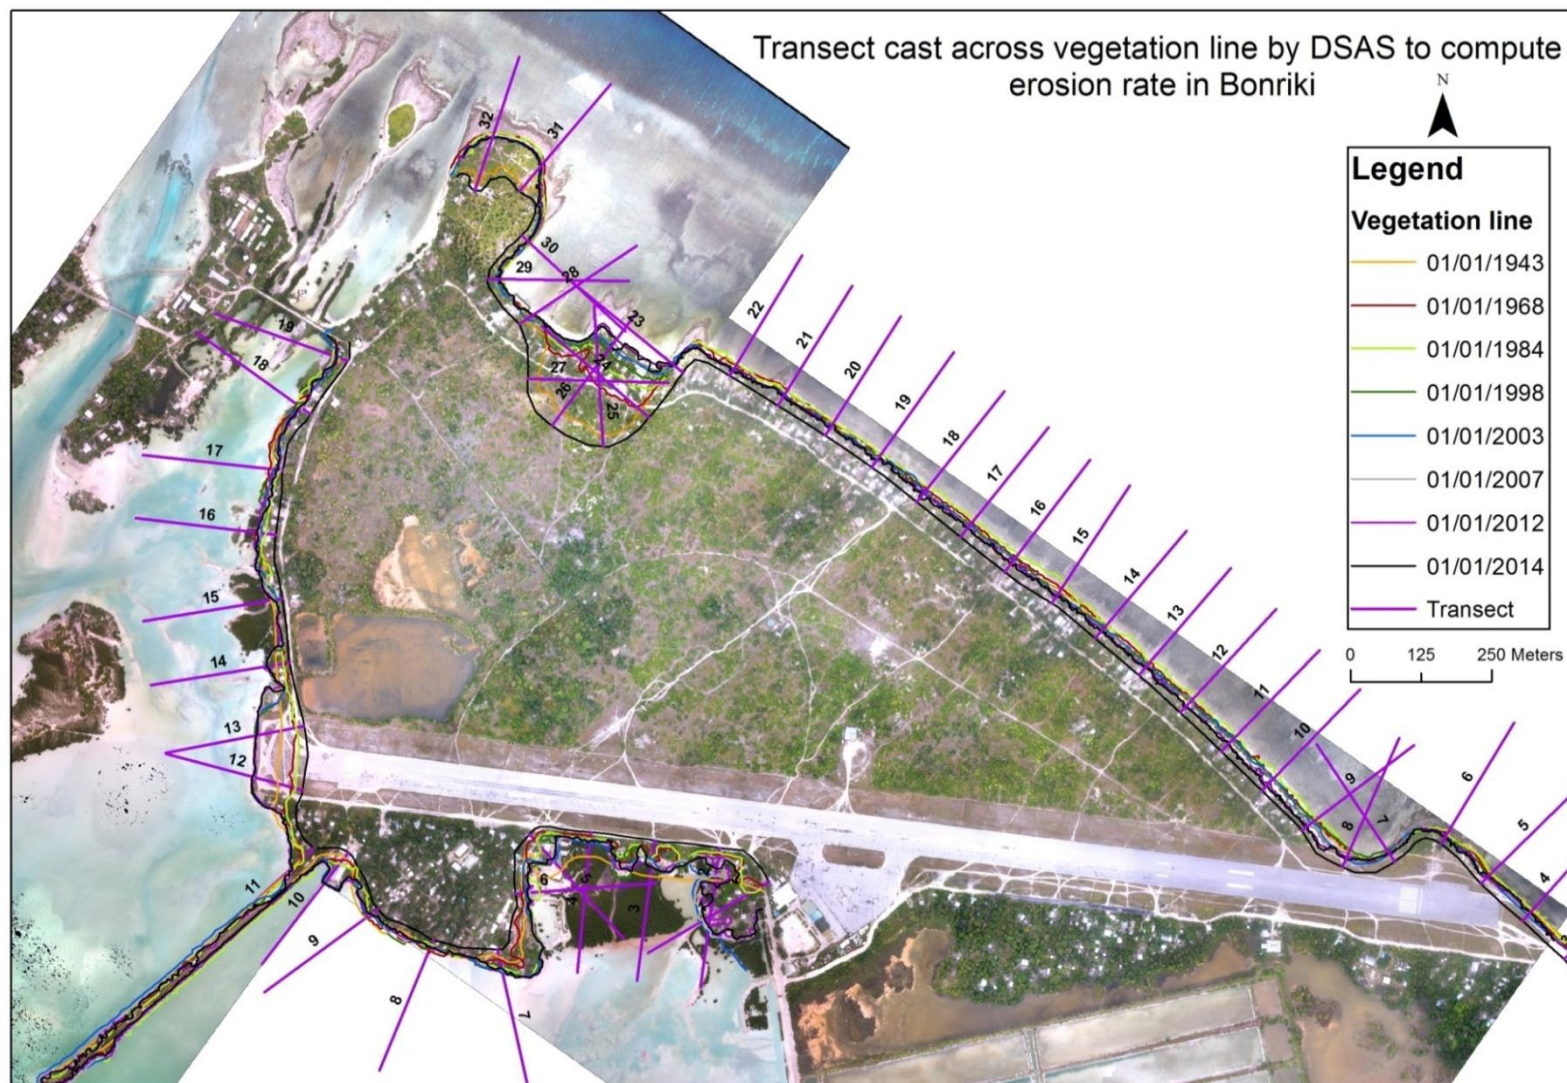
**Figure 4:** Transect cast used for Digital Shoreline Analysis System analysis for vegetation line from 1943 to 2014 at Bonriki

Transects for the shoreline analysis were at 100-m intervals as shown in Figure 4. Further analysis on DSAS output was done using the Matlab software package to compute and plot the WLR graphs for each cast on the ocean side and lagoon side.

In this study, eight historical shoreline positions were extracted to investigate shoreline change. Change rates were calculated for the period between 1943 and 2014 for the ocean side and lagoon side. The results show that there have been significant changes along the entire shoreline for the 71-year period. Change in shoreline positions were determined by creating 32 transects on the ocean side and 19 transects on the lagoon side, all of which are oriented perpendicular to the baseline at 100-m spacing alongshore by using DSAS software (Figure 4).

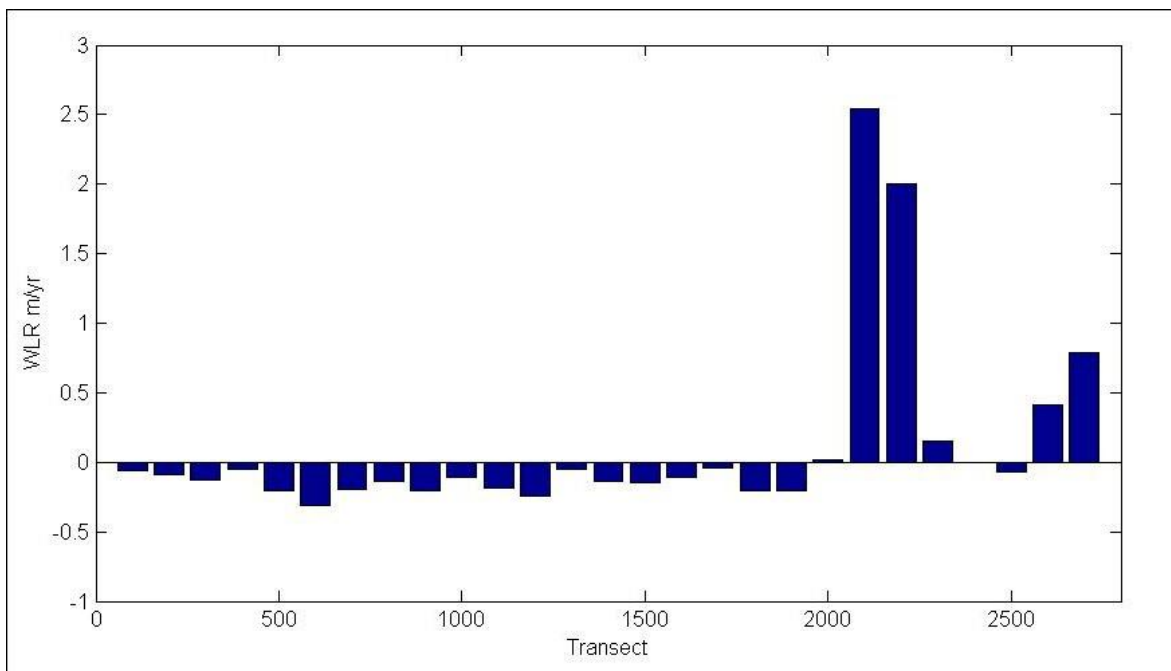
**Figure 6:** Erosion and accretion rates from 1943 to 2014 for the ocean side of Bonriki

On the ocean side, rates of shoreline movement from 1943 to 2014 range from -0.3 m/year to 2.5 m/year, where negative values represent erosion and positive values represent accretion (Figure 6). Results revealed that erosion dominates the ocean side shoreline with 70% of the cast transect recorded as erosion and 30% as accretion. The result agrees with the shoreline mapping done for the ocean side as shown in Table 3. The shoreline mapping survey revealed a large erosion scarp on the ocean side, from 50 cm to 1 m in height as seen in

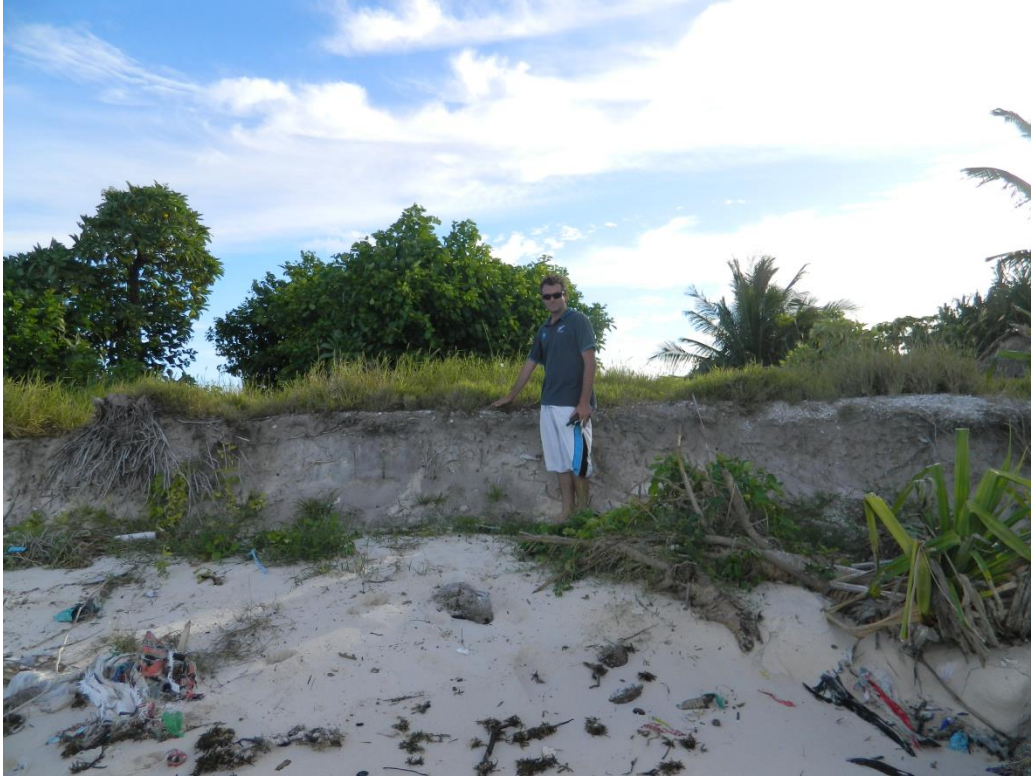
**Figure 7:** A one-meter high erosion scarp on the ocean side of Bonriki

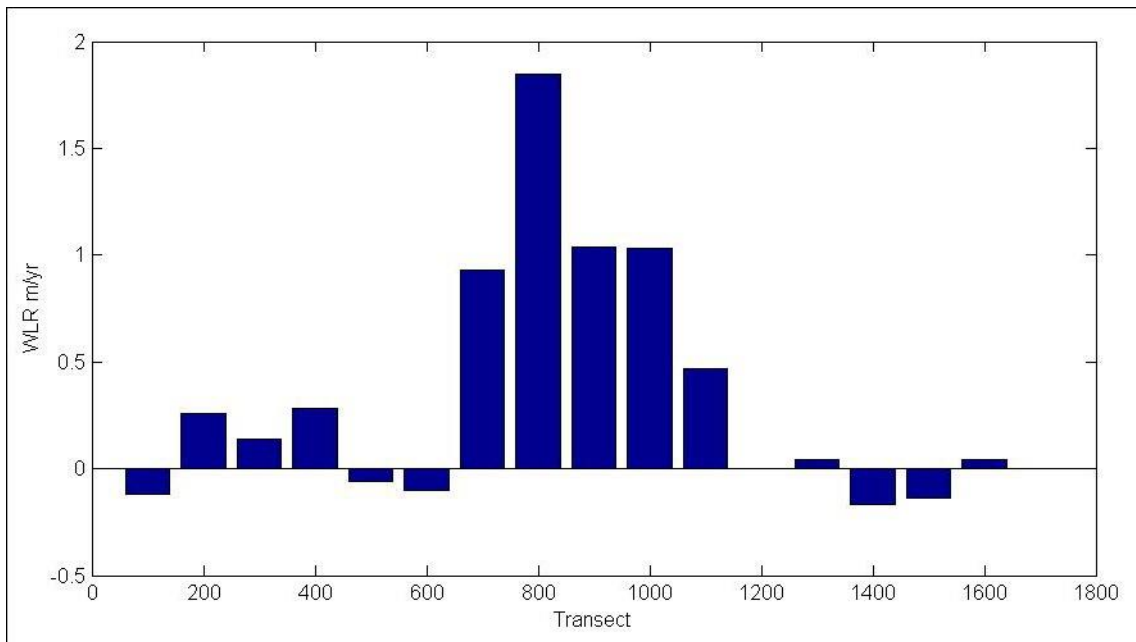
**Figure 8:** Erosion and accretion rates from 1943 to 2014 for the lagoon side of Bonriki

On the lagoon side, the rates ranges from -0.17 m/year to 1.85 m/year. Where negative values represent erosion, and positive values represent accretion (Figure 8). The results revealed that accretion dominates the lagoon shoreline, with 60% of the cast transect recorded as accretion and 40% erosion. This is a result of the major reclamation project on Bonriki–Taborio, and closing of the causeway, which caused the land area to increase from 1968 to 1998.

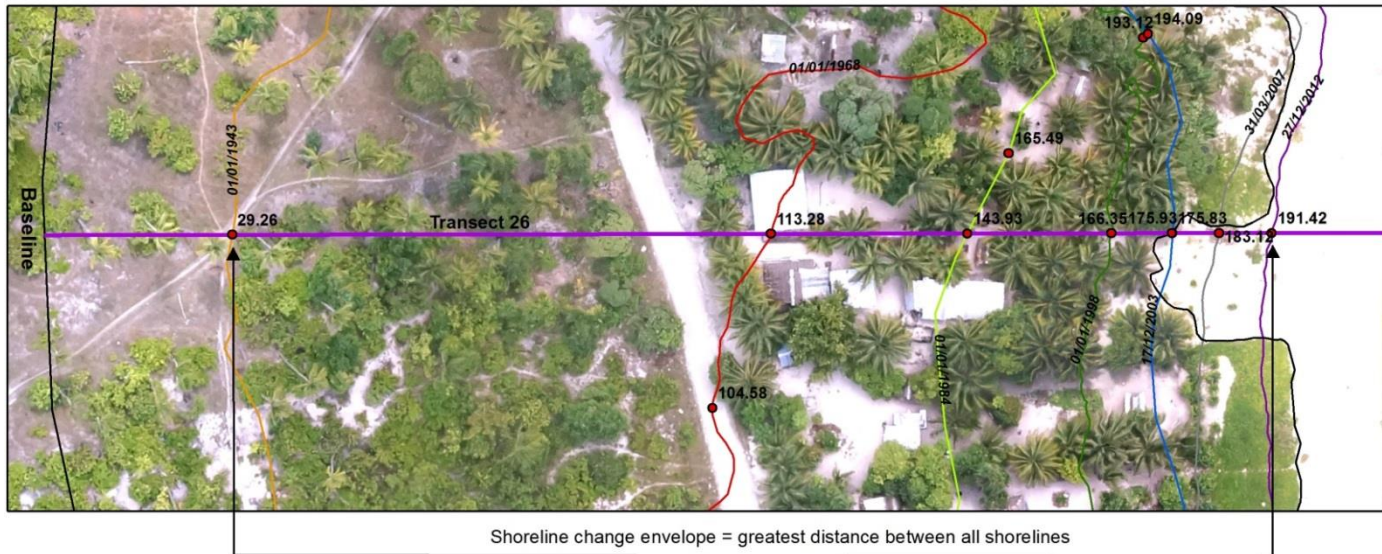
**Figure 10:** Shoreline change envelope for Transect 26, which was on the ocean side of Bonriki

The SCE for Transect 26, calculated as the distance between the 2012 and 1943 shorelines, is 162.16 m. This distance is not associated with the age of the shorelines.

For Transect 26, an NSM of 146.57 m is calculated as the distance between the most recent shoreline from 2014 and the oldest shoreline from 1943.

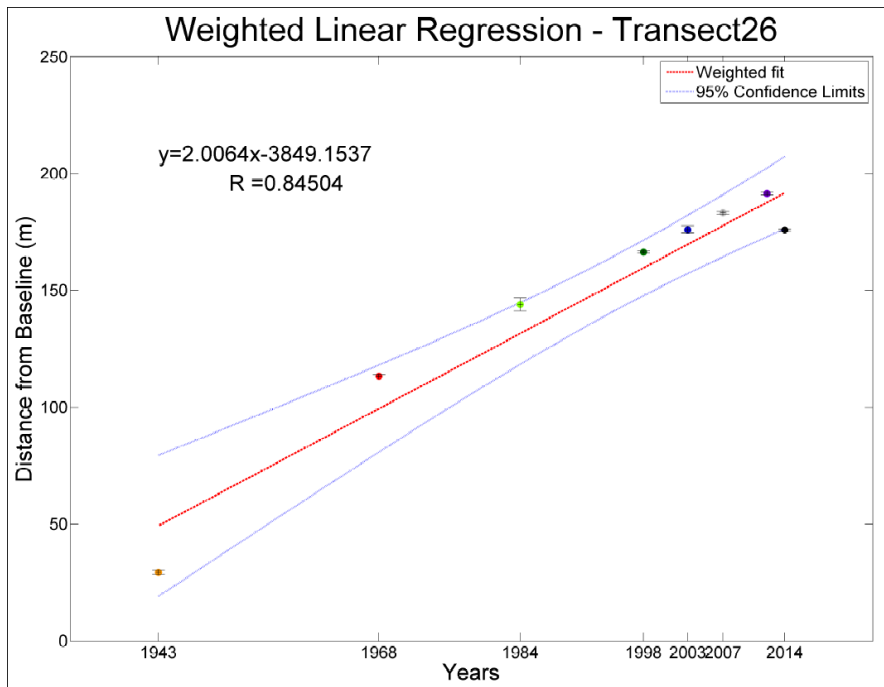
**Figure 11:** An example of continuous accretion on the ocean side of Bonriki

Transects that showed continuous accretion from 1943 to 2014, include transects 25 and 26, with an NSM of 147 m. The accretion rates ranged from 2.0 m/year to 2.54 m/year for these two transects.

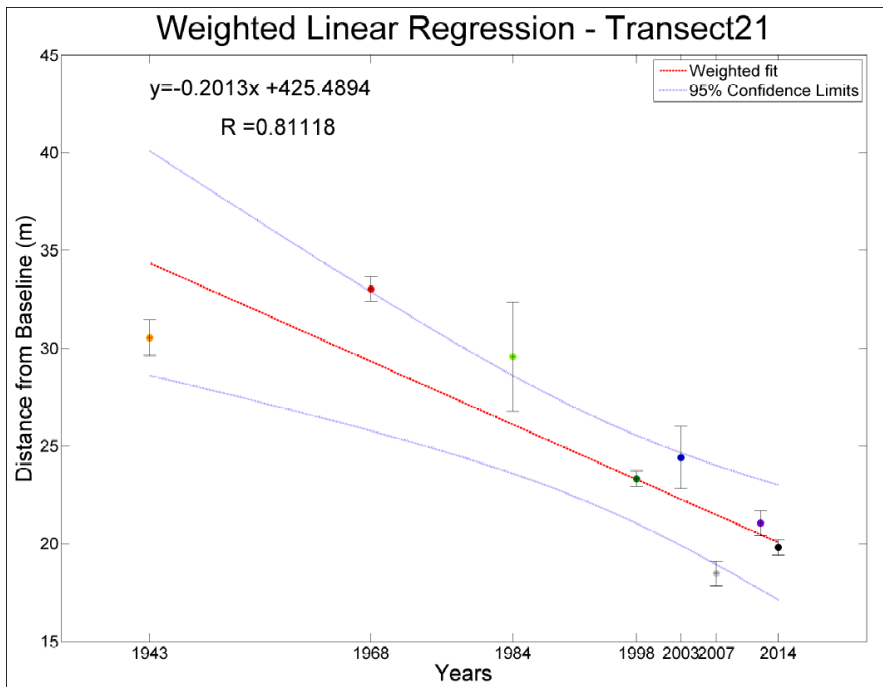
**Figure 13:** An example of continuous erosion on the ocean side of Bonriki.

Only Transect 21 showed persistent erosion from 1943 to 2014, with an NSM of 12 m. The erosion rate was -0.2 m/year.

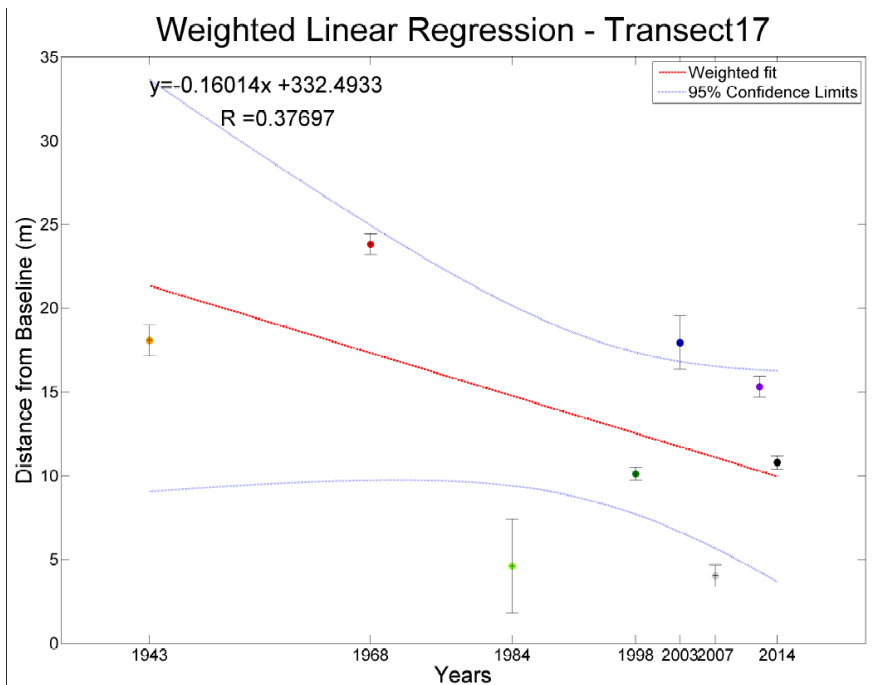
**Figure 14:** An example showing no trend in accretion or erosion at Bonriki. Note that the data points are poorly constraint.

For ocean side transects 4, 5, 20, 23 and 29, and for lagoon side transects 6, 9, 11, 15, 17, 18 and 19, there were no trends in accretion and erosion and no patterns of change could be extracted. Details for Transect 17 are shown in Figure 14 below.

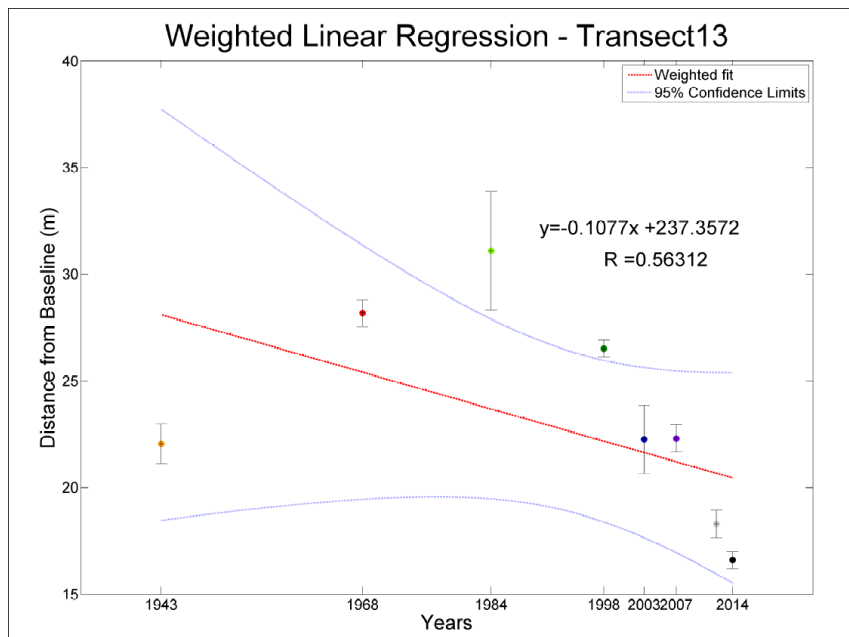
**Figure 16:** An example showing two different trends, one from accretion and the other erosion. The inflection point around 1984 can be clearly identified

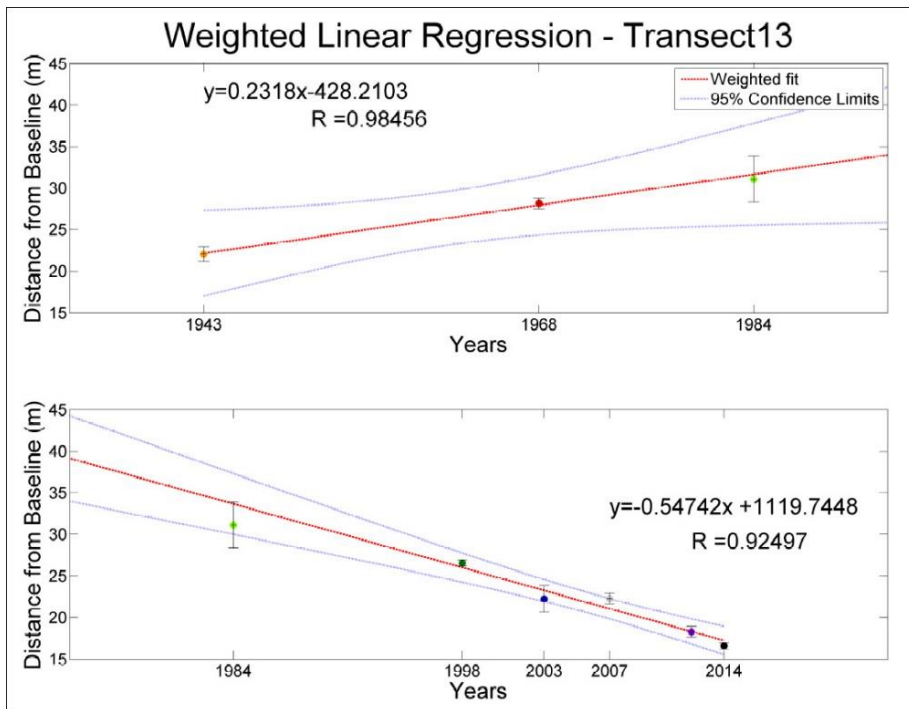
**Figure 17:** Weighted linear regression for Transect 13 over two periods: 1943–1984 and 1984–2014.

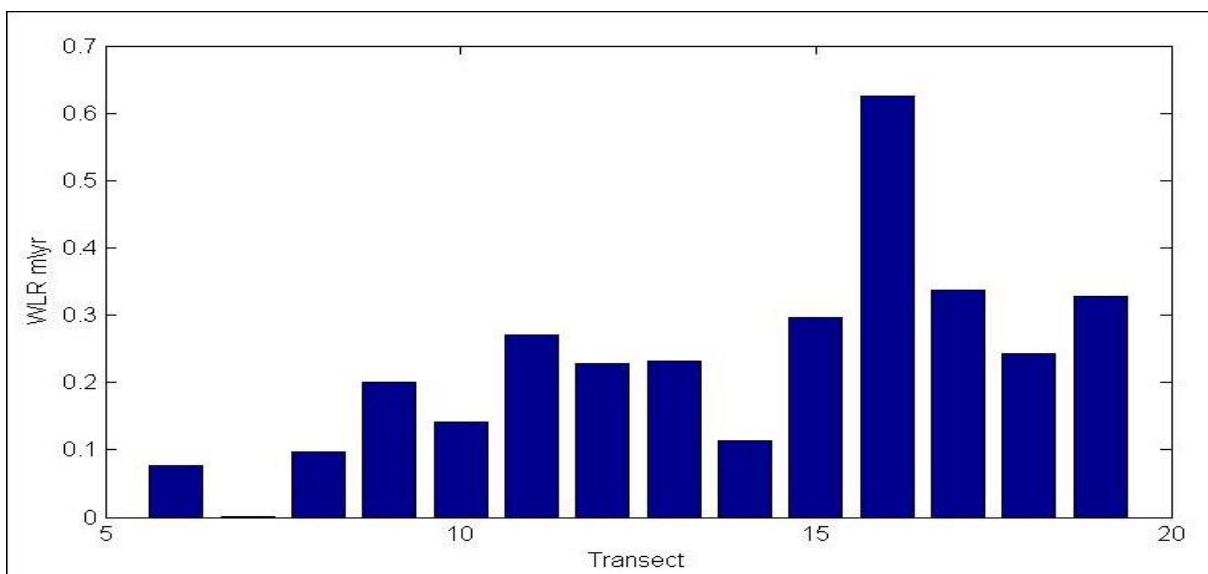
**Figure 18:** Accretion rates from 1943 to 1984 for the ocean side of Bonriki

Change rates were calculated for the period 1943–1984 as seen in Figure 18. The results show that there has been significant accretion along the entire ocean coastline for the 41 year period. The average accretion rate was 0.23 m/year. The overall accretion rate ranges from 0.08 m/year to 0.63 m/year. Significant accretion from 1943 to 1984 suggests that the shoreline was recovering from heavy human impact on the island during World War II when Bonriki was an airbase for the US Navy. Two airstrips were built in addition to other infrastructure.

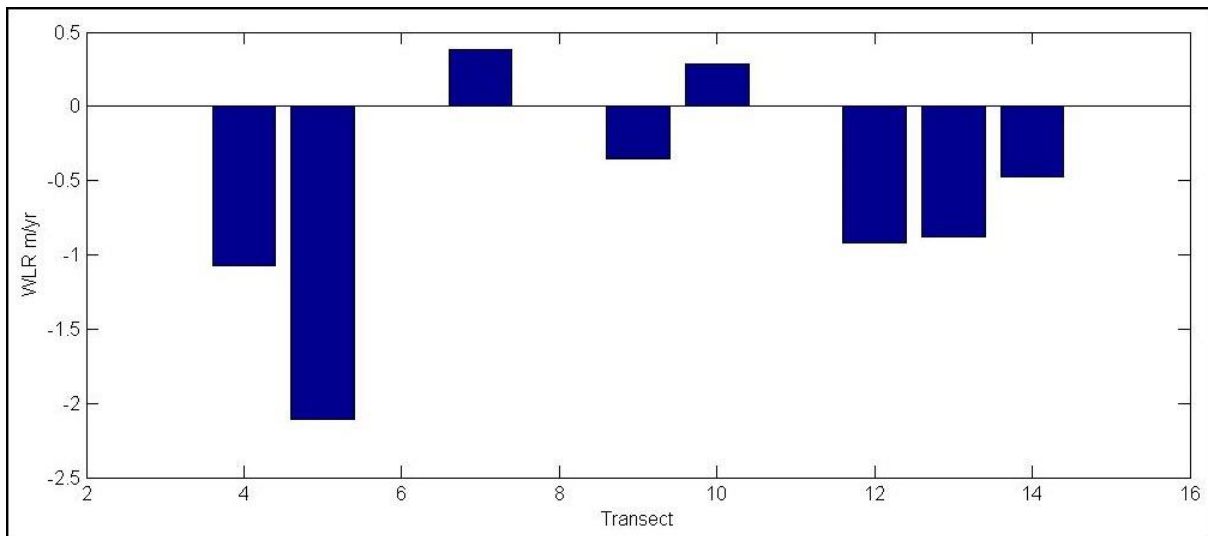
**Figure 19:** Erosion and accretion rates from 1943 to 1984 for the lagoon side of Bonriki

On the lagoon side, there was both accretion and erosion from 1943 to 1984. The accretion rate ranged from 0.29 m/year to 0.38 m/year and the erosion rate ranged from -0.35 m/year to -2.10 m/year as shown in Figure 19. This trend is the result of the major reclamation project on Bonriki–Taborio and the causeway closure from 1968 to 1998, which resulted in an increase in total land area.

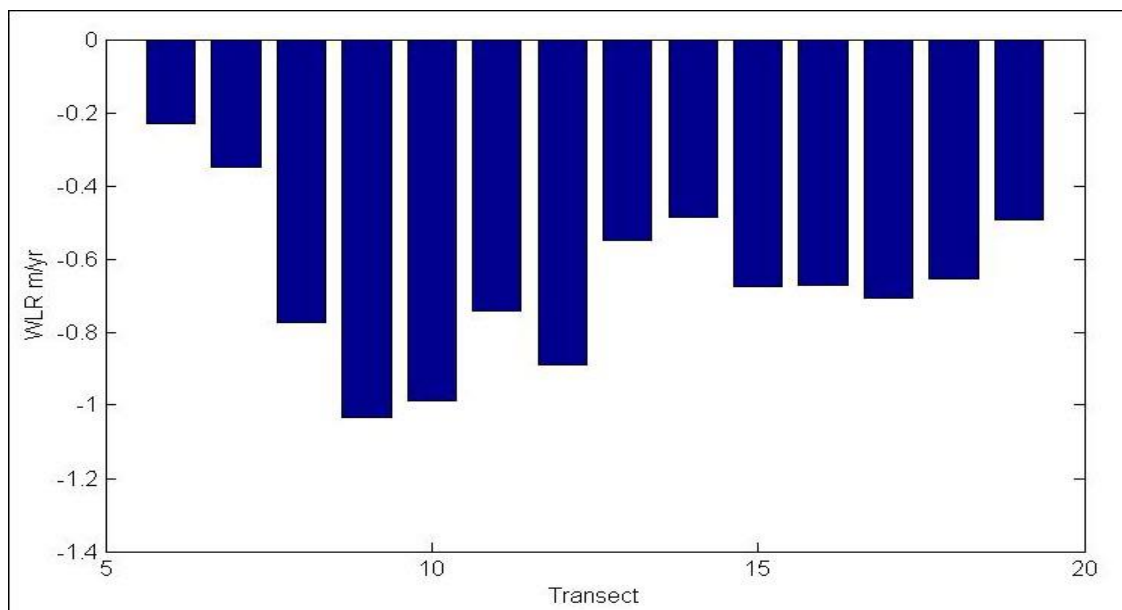
**Figure 21:** Erosion rates from 1984 to 2014 for the ocean side of Bonriki

The trend from 1984 to 2014 shows an opposite trend than that for 1943 to 1984 for transects 6–19. The results show that there has been erosion along the ocean coastline for the past 30 years as shown in Figure 21 and Figure 25. The average erosion rate was -0.68 m/year. The overall erosion rate ranged from -0.23 m/year to -0.49 m/year.

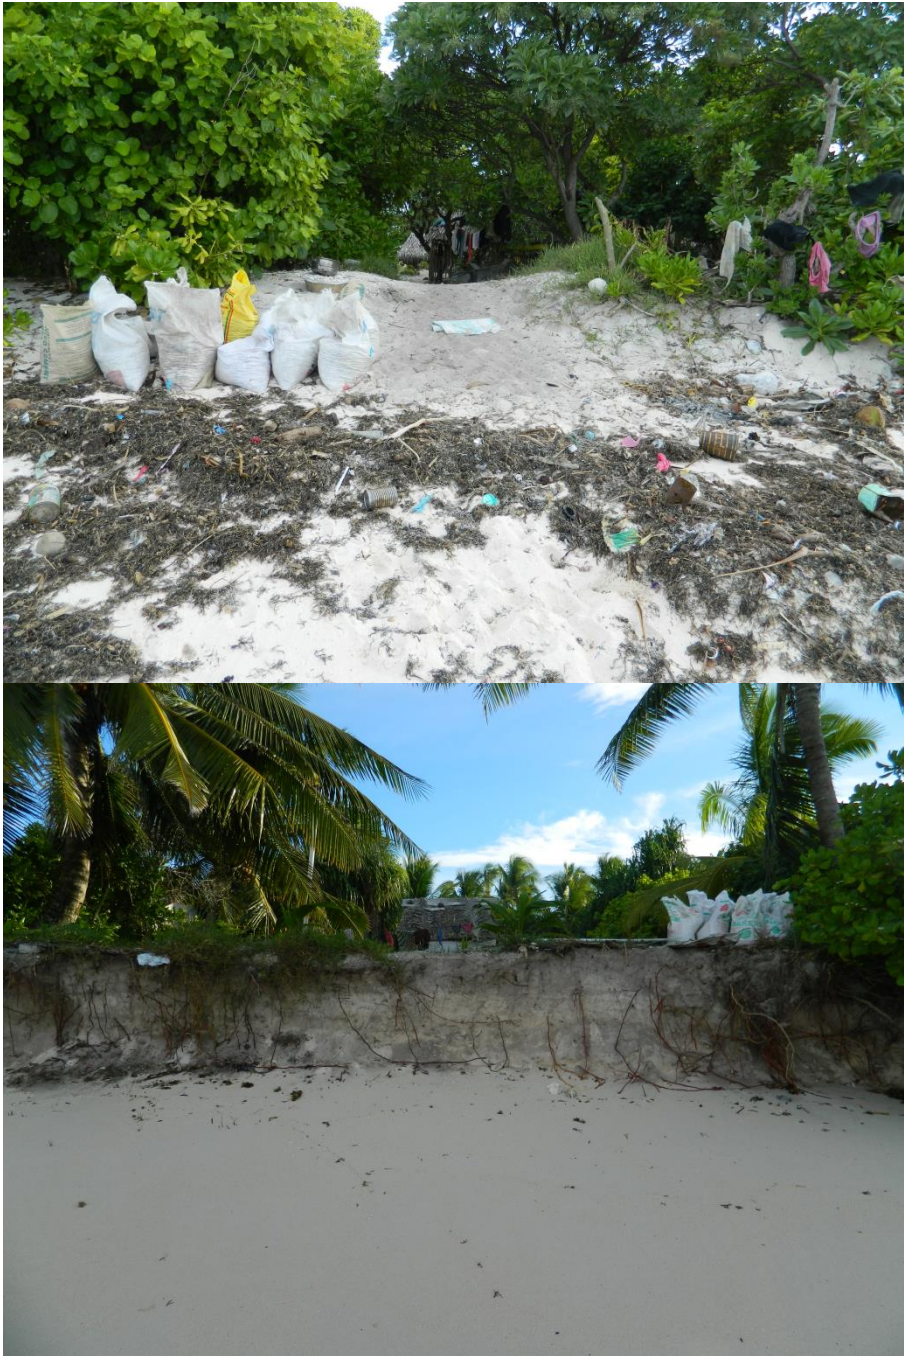
**Figure 22:** Beach mining on the ocean side of Bonriki. Note the bags containing beach material (aggregate) ready for sale and/or transport

As Biribo and Smith (1994) conservatively estimated in 1993, “private” aggregate extraction (meaning individuals selling or using aggregate, of which practically 100% would be sourced from the beach environment) was 4100 m<sup>3</sup> of sand and 8800 m<sup>3</sup> of gravel.

This erosion trend is mainly due to increasing population and development, leading to more encroachment onto the active beach, which is resulting in further interruptions to longshore sediment transport (Figure 22). As reported by Webb (2005), “this is evident everywhere on this coast and is not only hastening the disintegration of this already disturbed beach system but the excavation pits which lay just behind the beach scarp, greatly weaken the beach structure and it is likely that a large storm will result in the loss of many meters of land and flooding”. Another factor is the presence of ad hoc seawalls, which were built by the local communities. These hard structures can lead to further erosion, rather than protection of the coast (Figure 23).

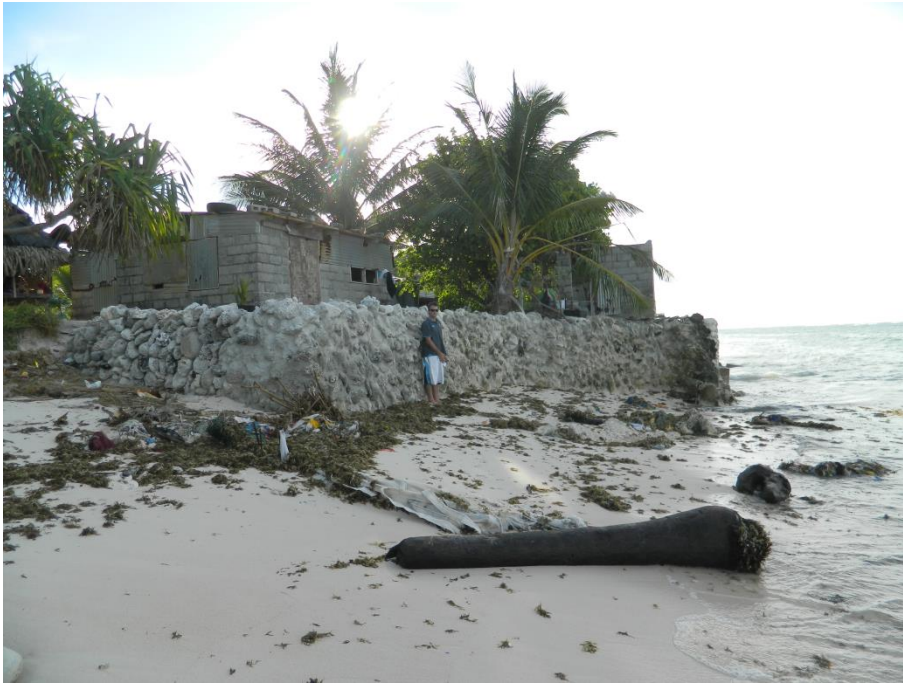
**Figure 23:** A seawall structure at Bonriki. Vertical hard structures such as these can lead to scour of the beach and interrupt longshore sediment transport, which can lead to erosion along the adjacent shoreline

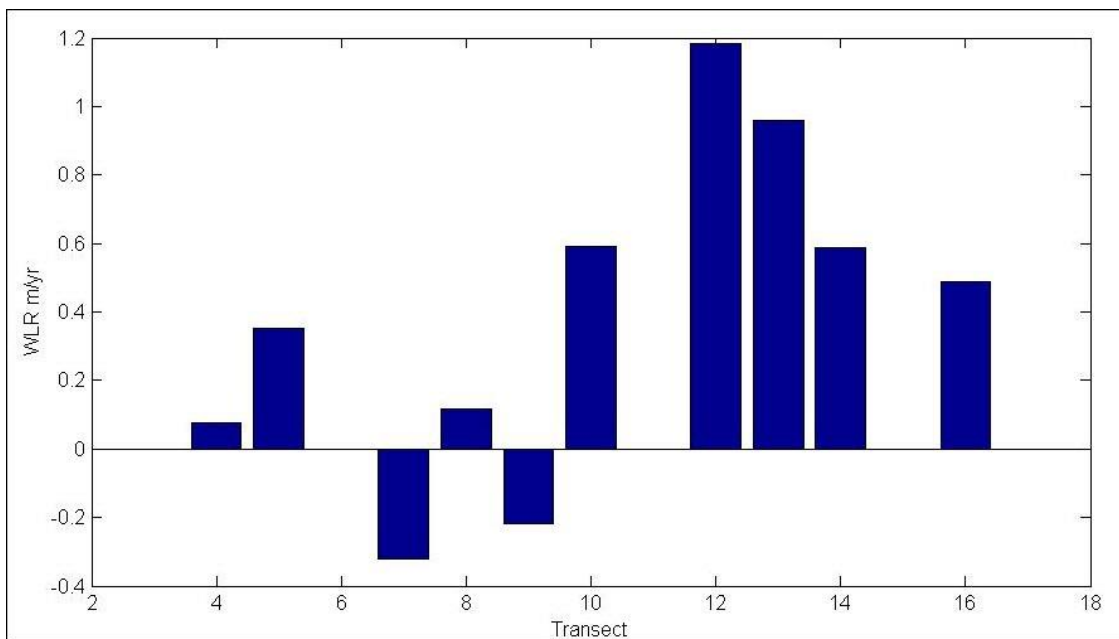
**Figure 24:** Erosion and accretion rates from 1984 to 2014 for the lagoon side of Bonriki

For the lagoon side there was both accretion and erosion from 1984 to 2014. The rate ranged from 0.00 m/year to 1.18 m/year and the erosion rate ranged from -0.22 m/year to -0.32 m/year as shown in Figure 24. This trend is due to reclamation towards lagoon side from 1984 onwards. Secondly the increase in mangroves coverage on the lagoon side provides a natural sediment trapping system potentially leading to accretion.

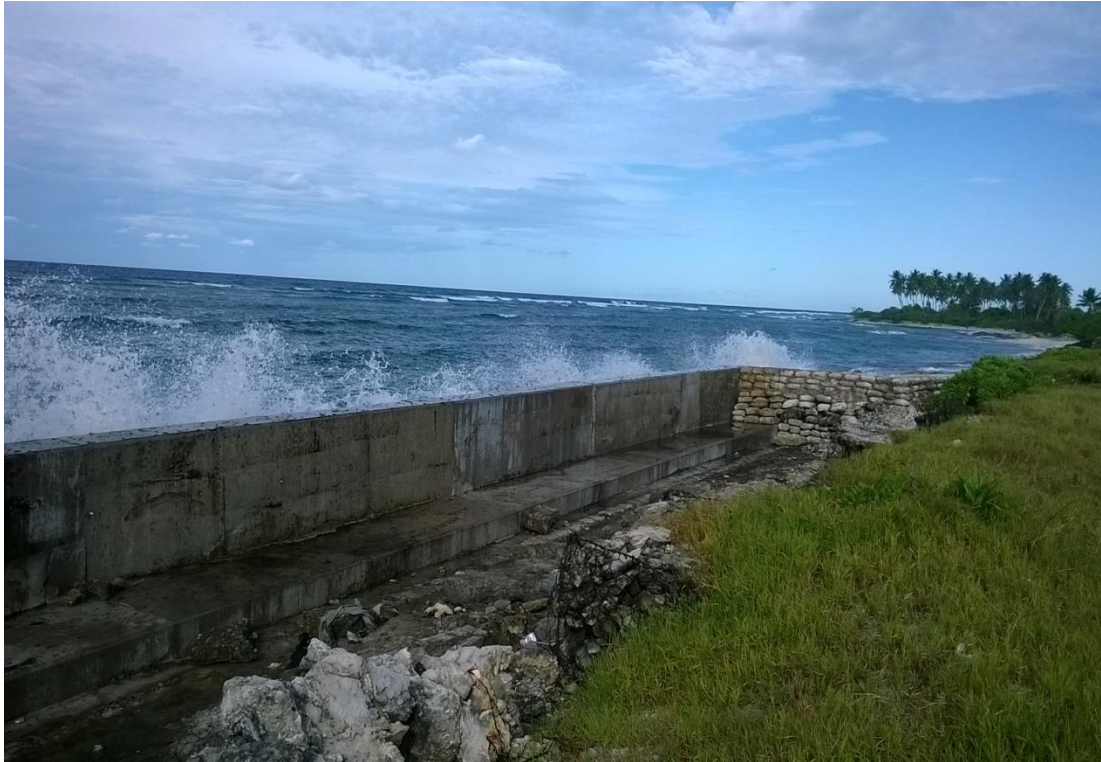
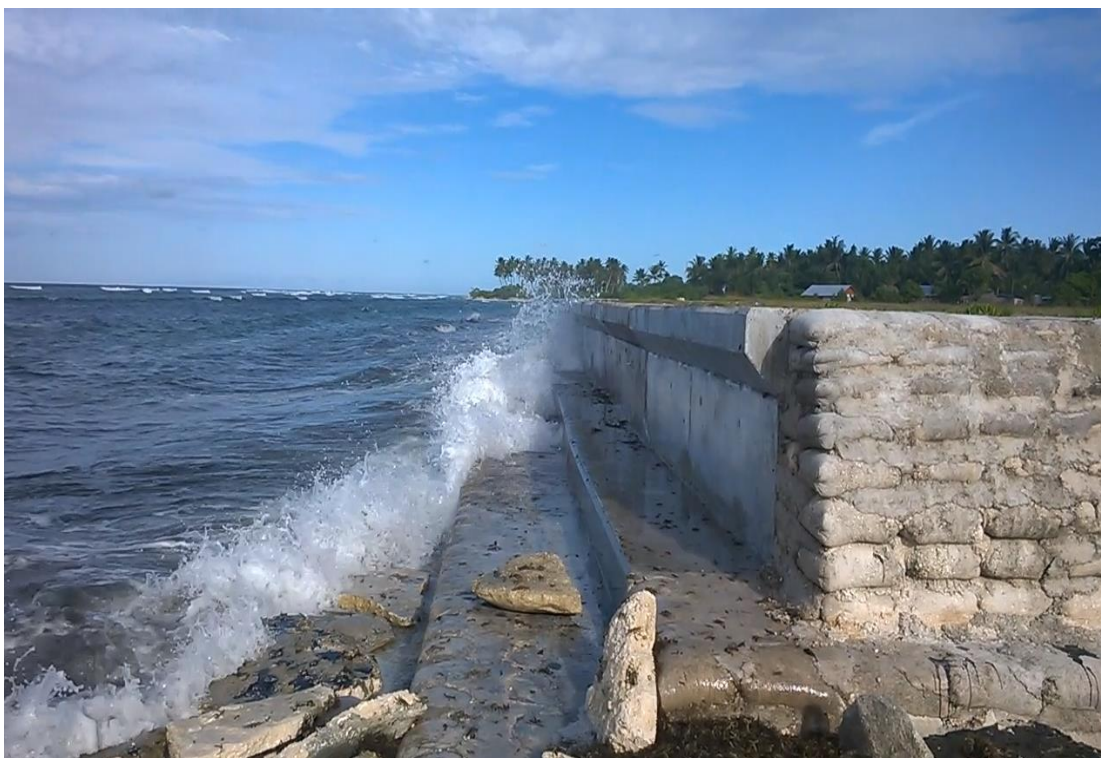
### Site 1

Site	Latitude	Longitude	Comments
1	1.380689	173.156663	Seawall at runway. Spring high tide – little wave Hs <0.5 m – Observing overtopping of seawall
2	1.381339	173.156072	Erosion beside seawall and beach mining
3	1.381597	173.155692	WWII tank and tar dumping on about 20-m stretch
4	1.381719	173.155453	Erosion scarp visible
5	1.381743	173.155156	Erosion up to the seawall for about 30 m
6			
7	1.381402	173.154819	Start of seawall
8	1.381308	173.15463	Issues in seawall construction – large erosion behind seawall causing a hole in the seawall.
9	1.381623	173.153629	1-m erosion scarp adjacent to seawall
10	1.381748	173.15352	House only 5 m from the erosion scarp
11	1.38231	173.153037	Privately constructed seawall 1 m in height
12	1.382572	173.152756	Extensive erosion scarp
13	1.383011	173.152379	Rubbish on the beach berm and erosion
14	1.384228	173.151064	Seawall start at approximately 1.5 m in height
15	1.384456	173.150735	End of seawall – 1 m erosion scarp – 75 m of a 1 m erosion scarp and rubbish
